NORTH COAST OFF CHANNEL SURVEY
SUBSEQUENT SITE EVALUATION FORM

River System: Sol Duc River

Site No.: S-324L-01
Site Name: The Pond
WRIA: 20.0324E (P)

DATE: 4/21 - 4/22/99

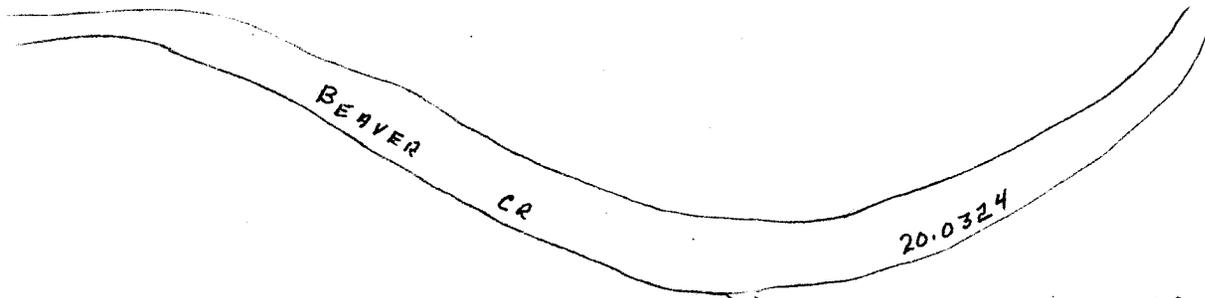
S-324L-01

- The pond is about 10 X 40 m and 1.2 m deep.
- Cover is provided by small woody debris, dark water coloration, shoreline brush and aquatic vegetation.

- The landowner has a road that crosses between the pond and Beaver Creek. There are two concrete culverts under the road. It does not appear there is enough road fill to cause the isolation of the pond.
- G.P.S. readings for the site: East - 1,074,552 North - 1,022,134

- Possible project type: Channel excavation
- Equipment access: Good, if private landowner agrees.
