RIVER: SOL DUC

TRIB: Beaver-Creek - 20.0324

SITE: S-324R-01, S-324R-02

DATE: 5/99

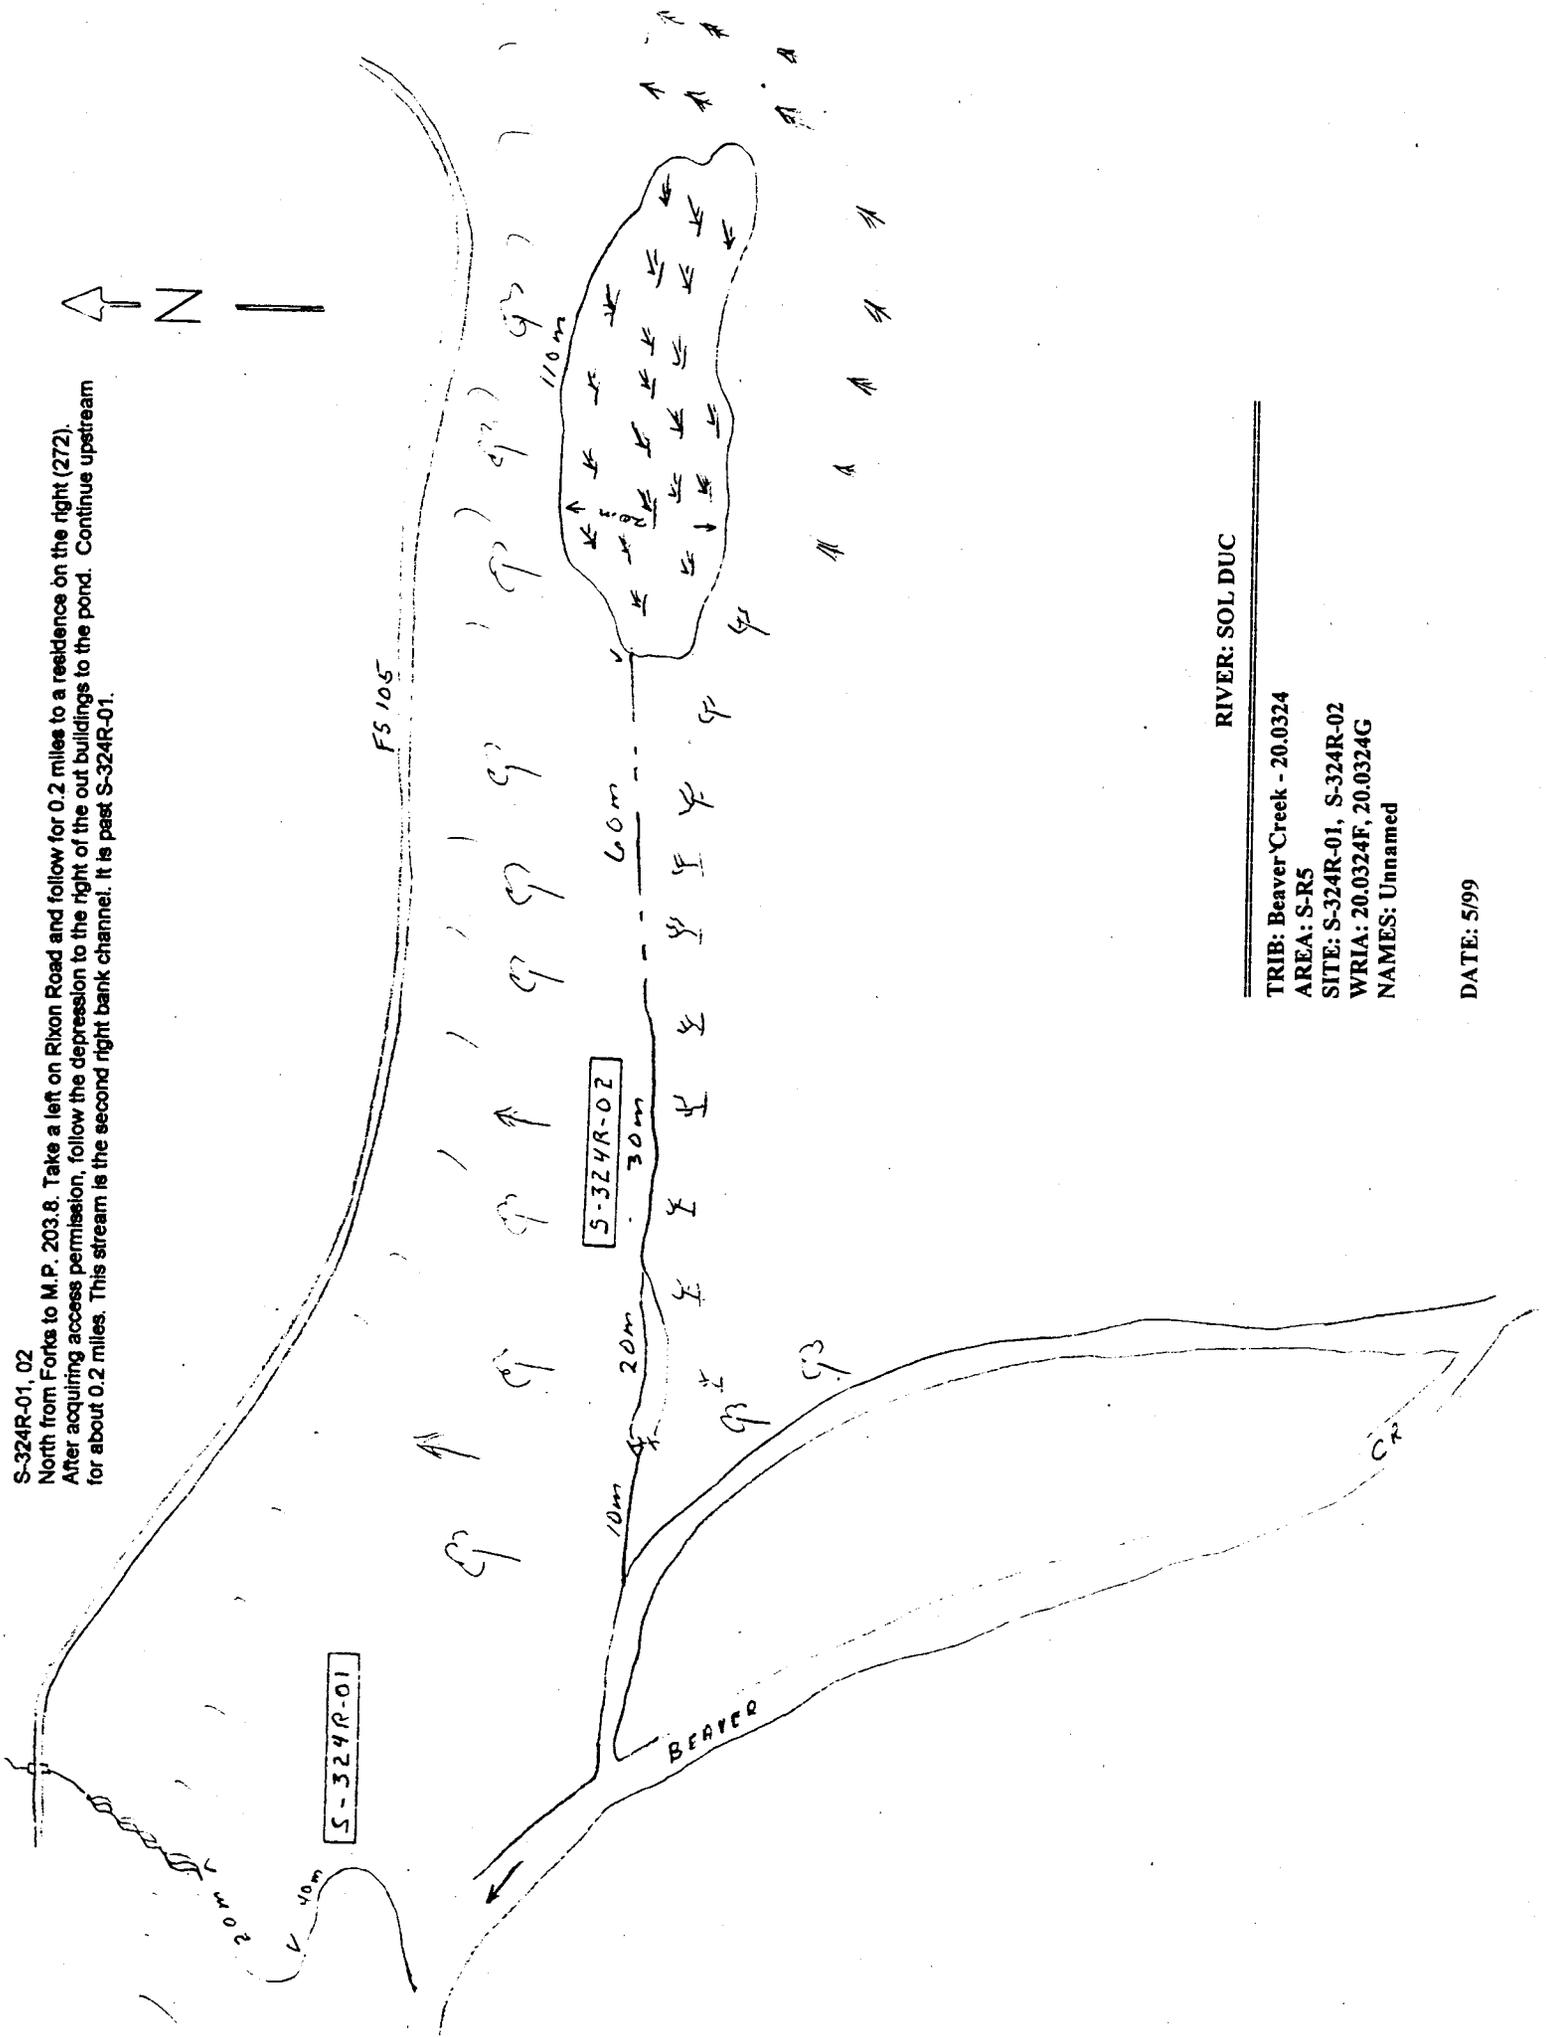
North from Forks to M.P. 203.8. Take a left on Rixon Road and follow for 0.2 miles to a residence on the right (272). After acquiring access permission, follow the depression to the right of the out buildings to the pond. Continue upstream for about 0.2 miles. This stream is the second right bank channel. It is past S-324R-01.
