RIVER: SOL DUC

TRIB: Beaver Creek - 20.0324
AREA: S-R5
SITE: S-324R-03
WRJA: 20.03241
NAMES: R.B. Slough

DATE: 5/99

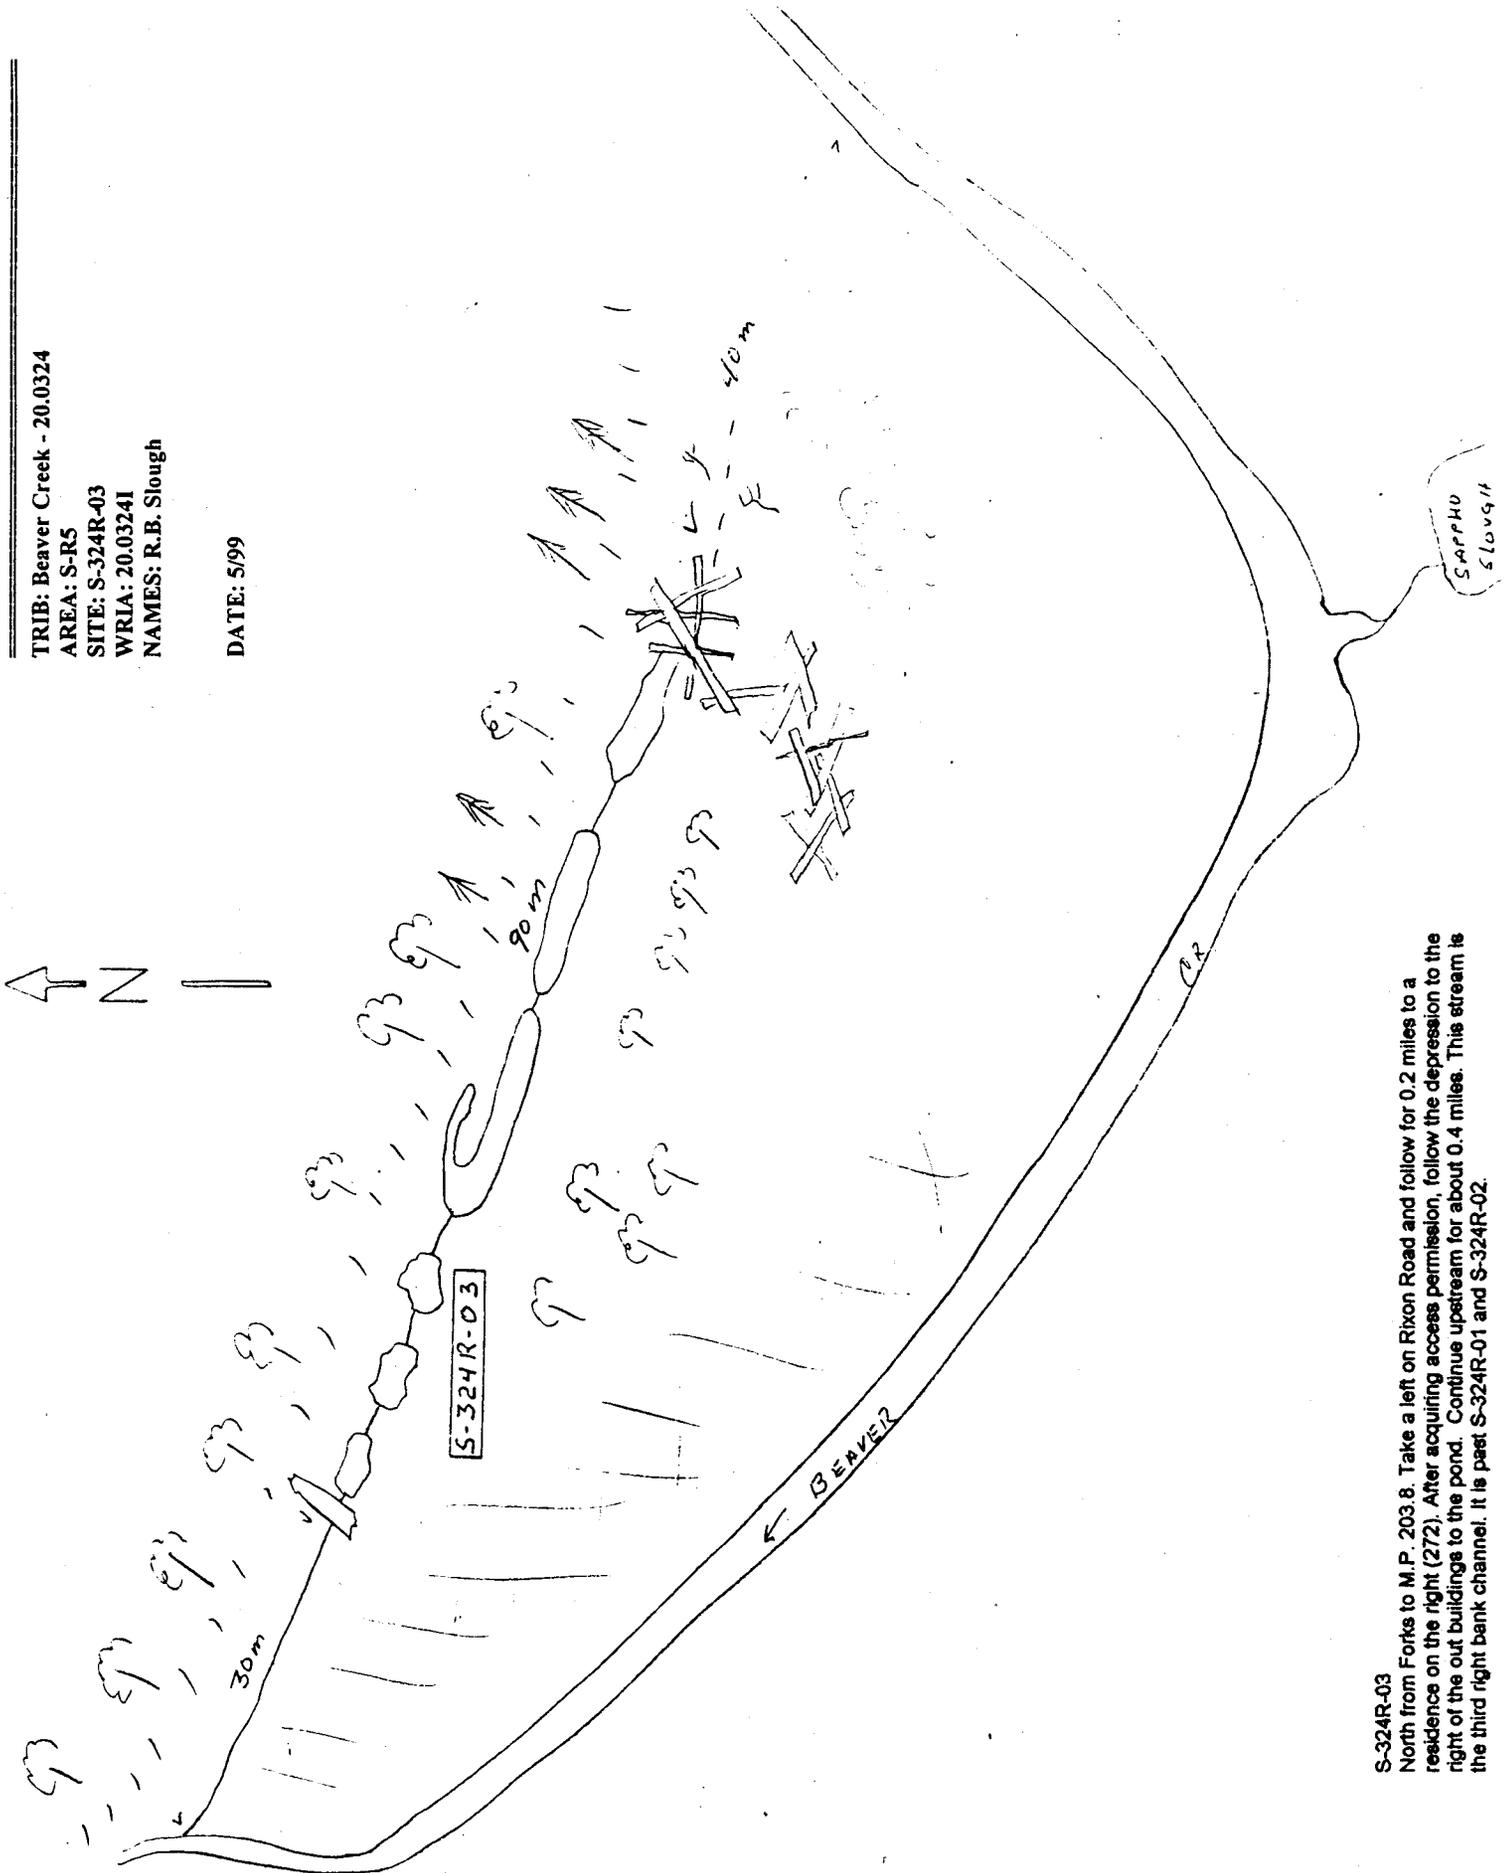
S-324R-03
North from Forks to M.P. 203.8. Take a left on Rixon Road and follow for 0.2 miles to a residence on the right (272). After acquiring access permission, follow the depression to the right of the out buildings to the pond. Continue upstream for about 0.4 miles. This stream is the third right bank channel. It is past S-324R-01 and S-324R-02.
