SITE NUMBER: SH-L2-01

NORTH COAST OFF CHANNEL SITE INVENTORY DATA

RIVER SYSTEM: S.F. Hoh **DATE:** 7/27/88 **OBSERVER:** Young

NORTH COAST OFF CHANNEL SURVEY
SUBSEQUENT SITE EVALUATION FORM

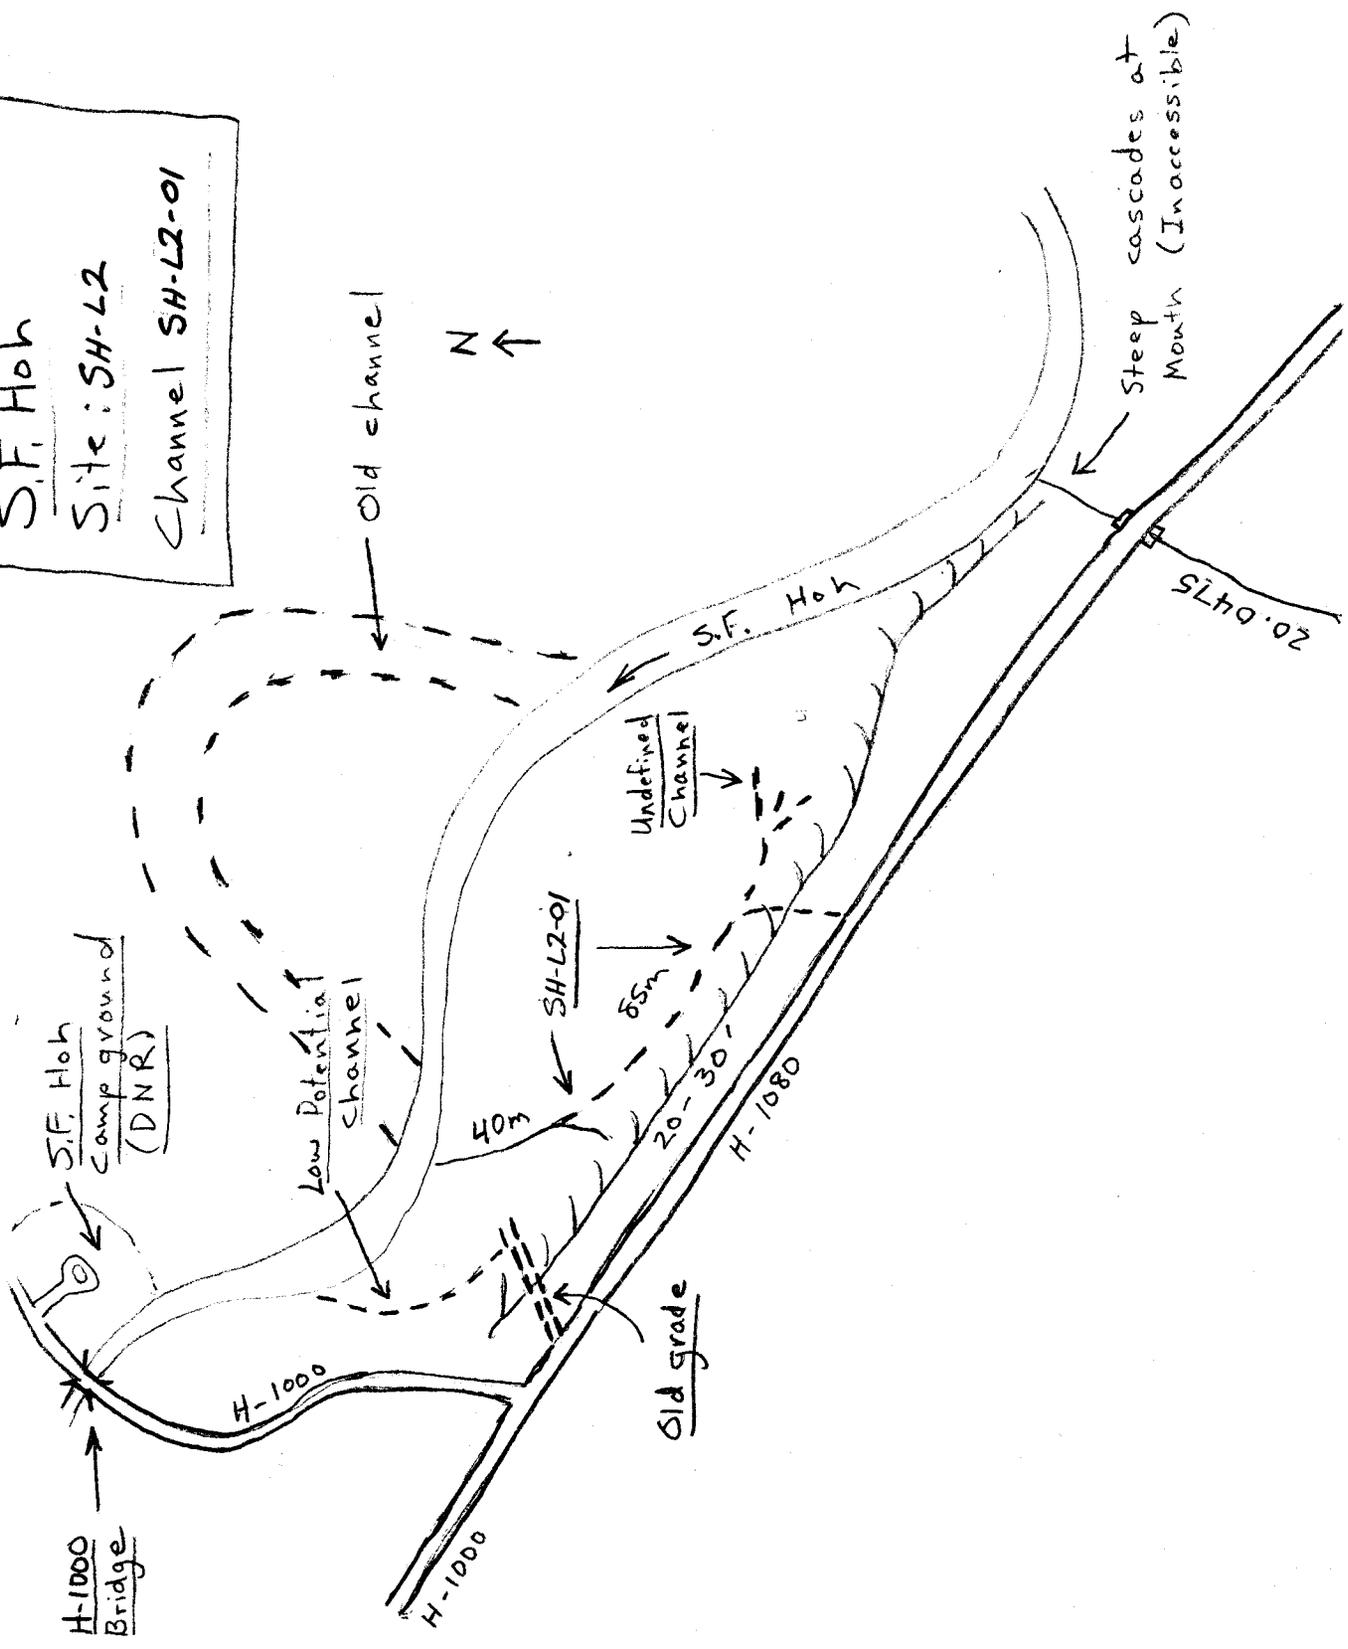
S.F. Hoh
Site: SH-L2
Channel SH-L2-01

COMMENTS & RECOMMENDATIONS: SH-L2-01 is a wall based channel which lies just below the H-1080 road about 0.25 miles east of the H-1000/H-1080 junction. It appears to be fed primarily by small valley wall tribs but may also on occasion receive some overflow from the river. A small amount of water was seen trickling through the lower 40 m of the channel. Some winter rearing may occur here but will need to see this one during the rainy season to determine if normal winter flows are significant.
