SITE INFORMATION

Site Identifier :	SS12LB2	Landowner Type :	Federal
Site Name :		Landowner Name :	USFS
WRIA :	05.0001X	Address :	
Region :	NS	Address2 :	
Trib to :	SF Stillaguamish	City :	
River Mile :	62.50	State :	
River System :	SF Stillaguamish	Zipcode :	
Legal Description :	SW16T30NR10E	Phone :	
County :	Snohomish	Coordinates	
Habitat Type :	overflow channel	East:	1,746,571.00 North: 1,004,990.00

Field Survey Information

Date : 7/15/02 **Observer :** Barkdull **Survey Type :** initial

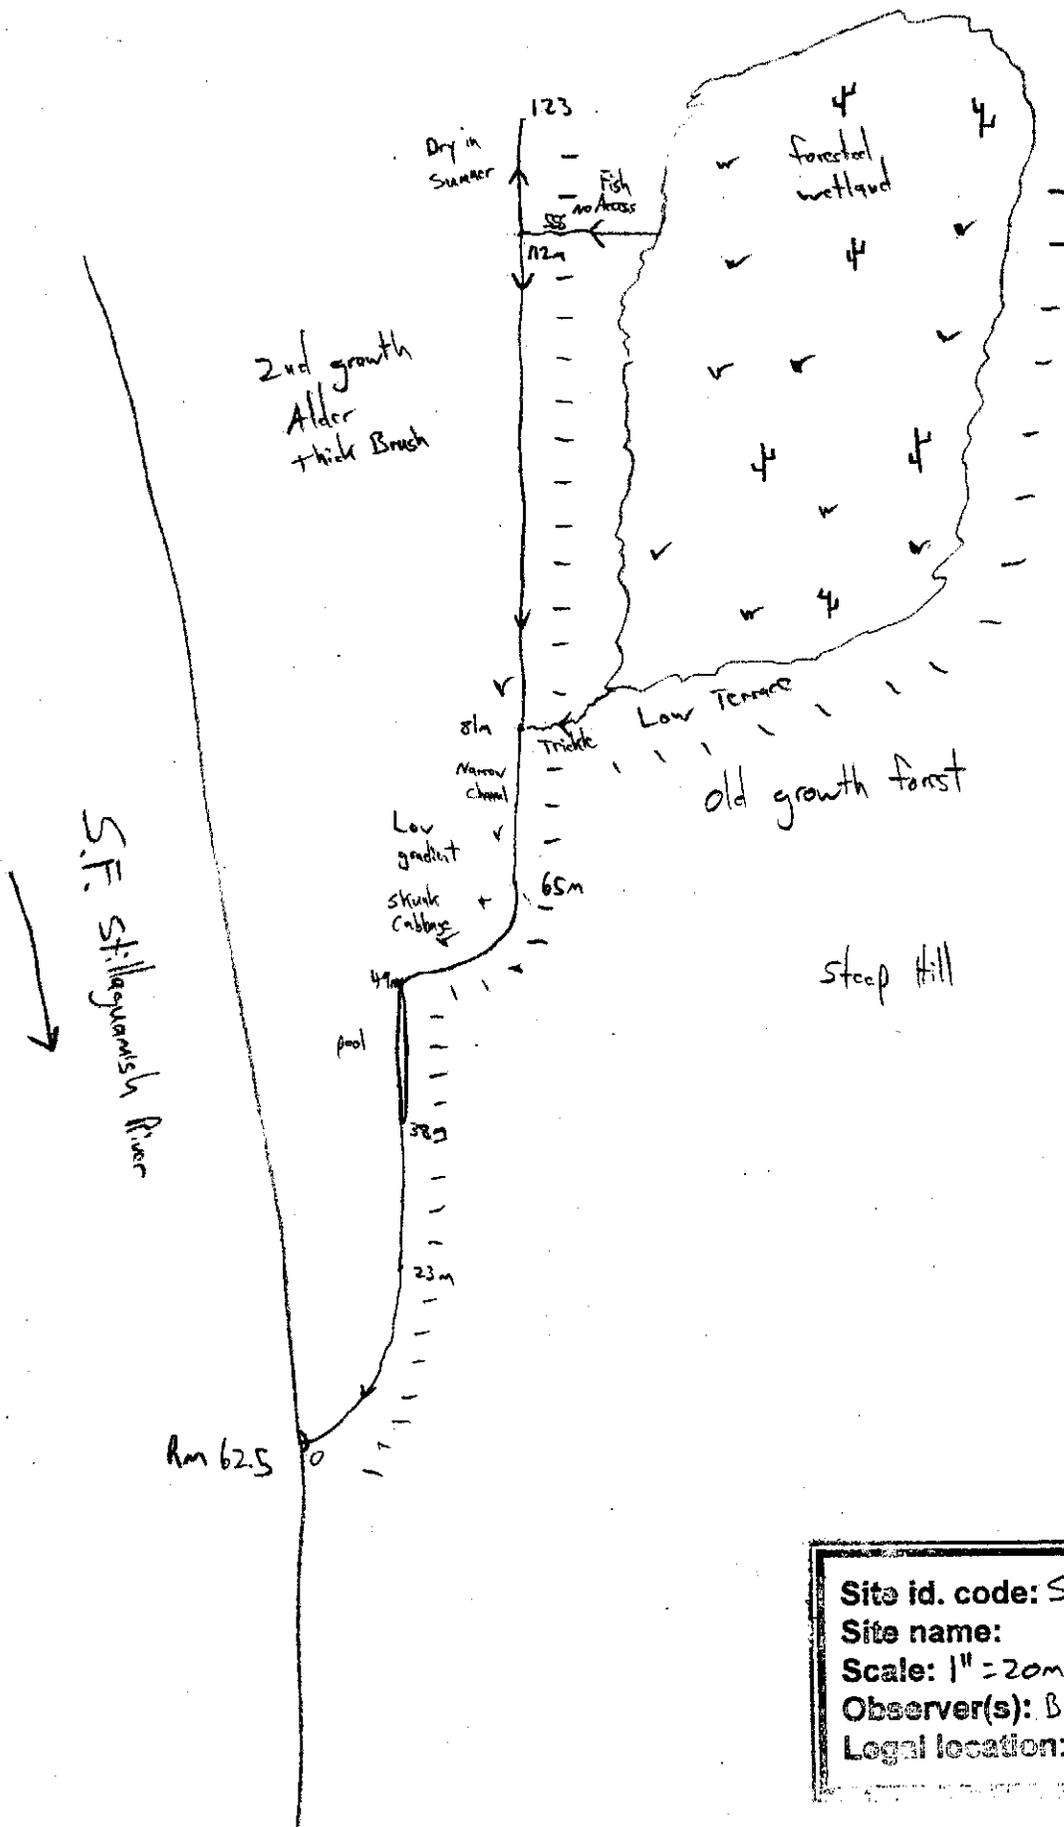
S.F. Stikine River

Site id. code: SS12LB2
 Site name:
 Scale: 1" = 20m
 Observer(s): B. Barkdull
 Legal location: SW16, T30N, R10E

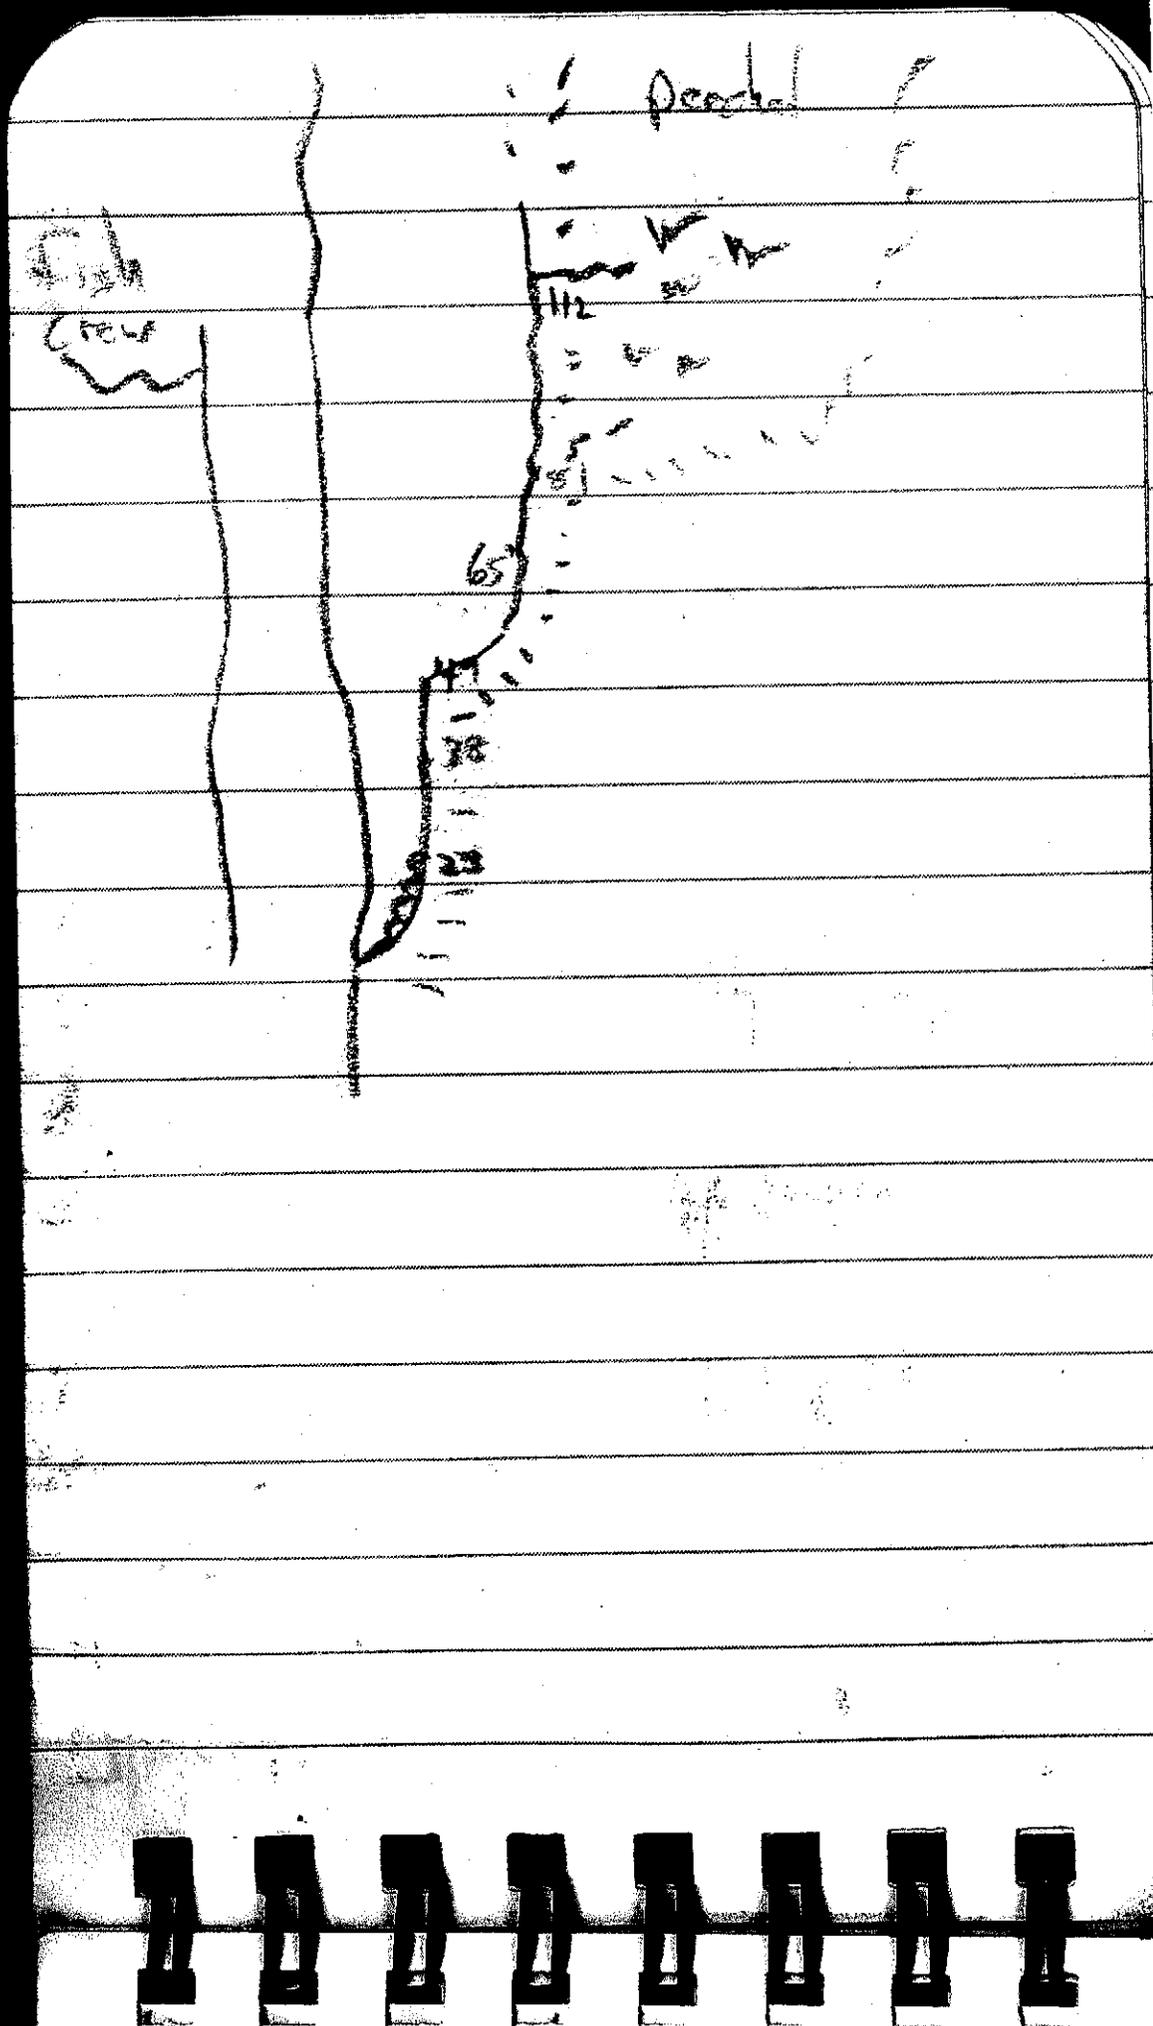
SS 12 LB 2

7/15/02 LD tub 2.5 x 0.01 m
 100 m below fish crew cr.
 Maxima 53, tub 4.5" good entrance
 0.0 1.5 mud bottom w/ Boulder
 23 1.2 mixed Pools of riffs
 many fish present
 38 0.2 Boulder / riffs section
 49 1.5 Pooled
 65 0.2 narrow channel, short riffs
 81 1.0 forested wetland LD
 w/ triddle return
 112 0.5 series of disconnected
 pools, some tied to LB
 123 0.2 dry, many access in water
 123 start at tub
 138 no access, ends at wetland
 no fish observed moderate
 flood productivity

RM 62.5
 X 1146571
 Y 1000000
