SITE INFORMATION

Site Identifier :	SS13LB8	Landowner Type :	Federal
Site Name :		Landowner Name :	USFS
WRIA :	05.0001X	Address :	
Region :	NS	Address2 :	
Trib to :	SF Stillaguamish R	City :	
River Mile :	66.30	State :	
River System :	SF Stillaguamish R	Zipcode :	
Legal Description :	SW1/4S26T30NR10E	Phone :	
County :	Snohomish	Coordinates	
Habitat Type :	terrace tributary	East:	1,756,896.00
		North:	993,070.00

Field Survey Information

Date : 10/21/02 **Observer :** Barkdull **Survey Type :** initial

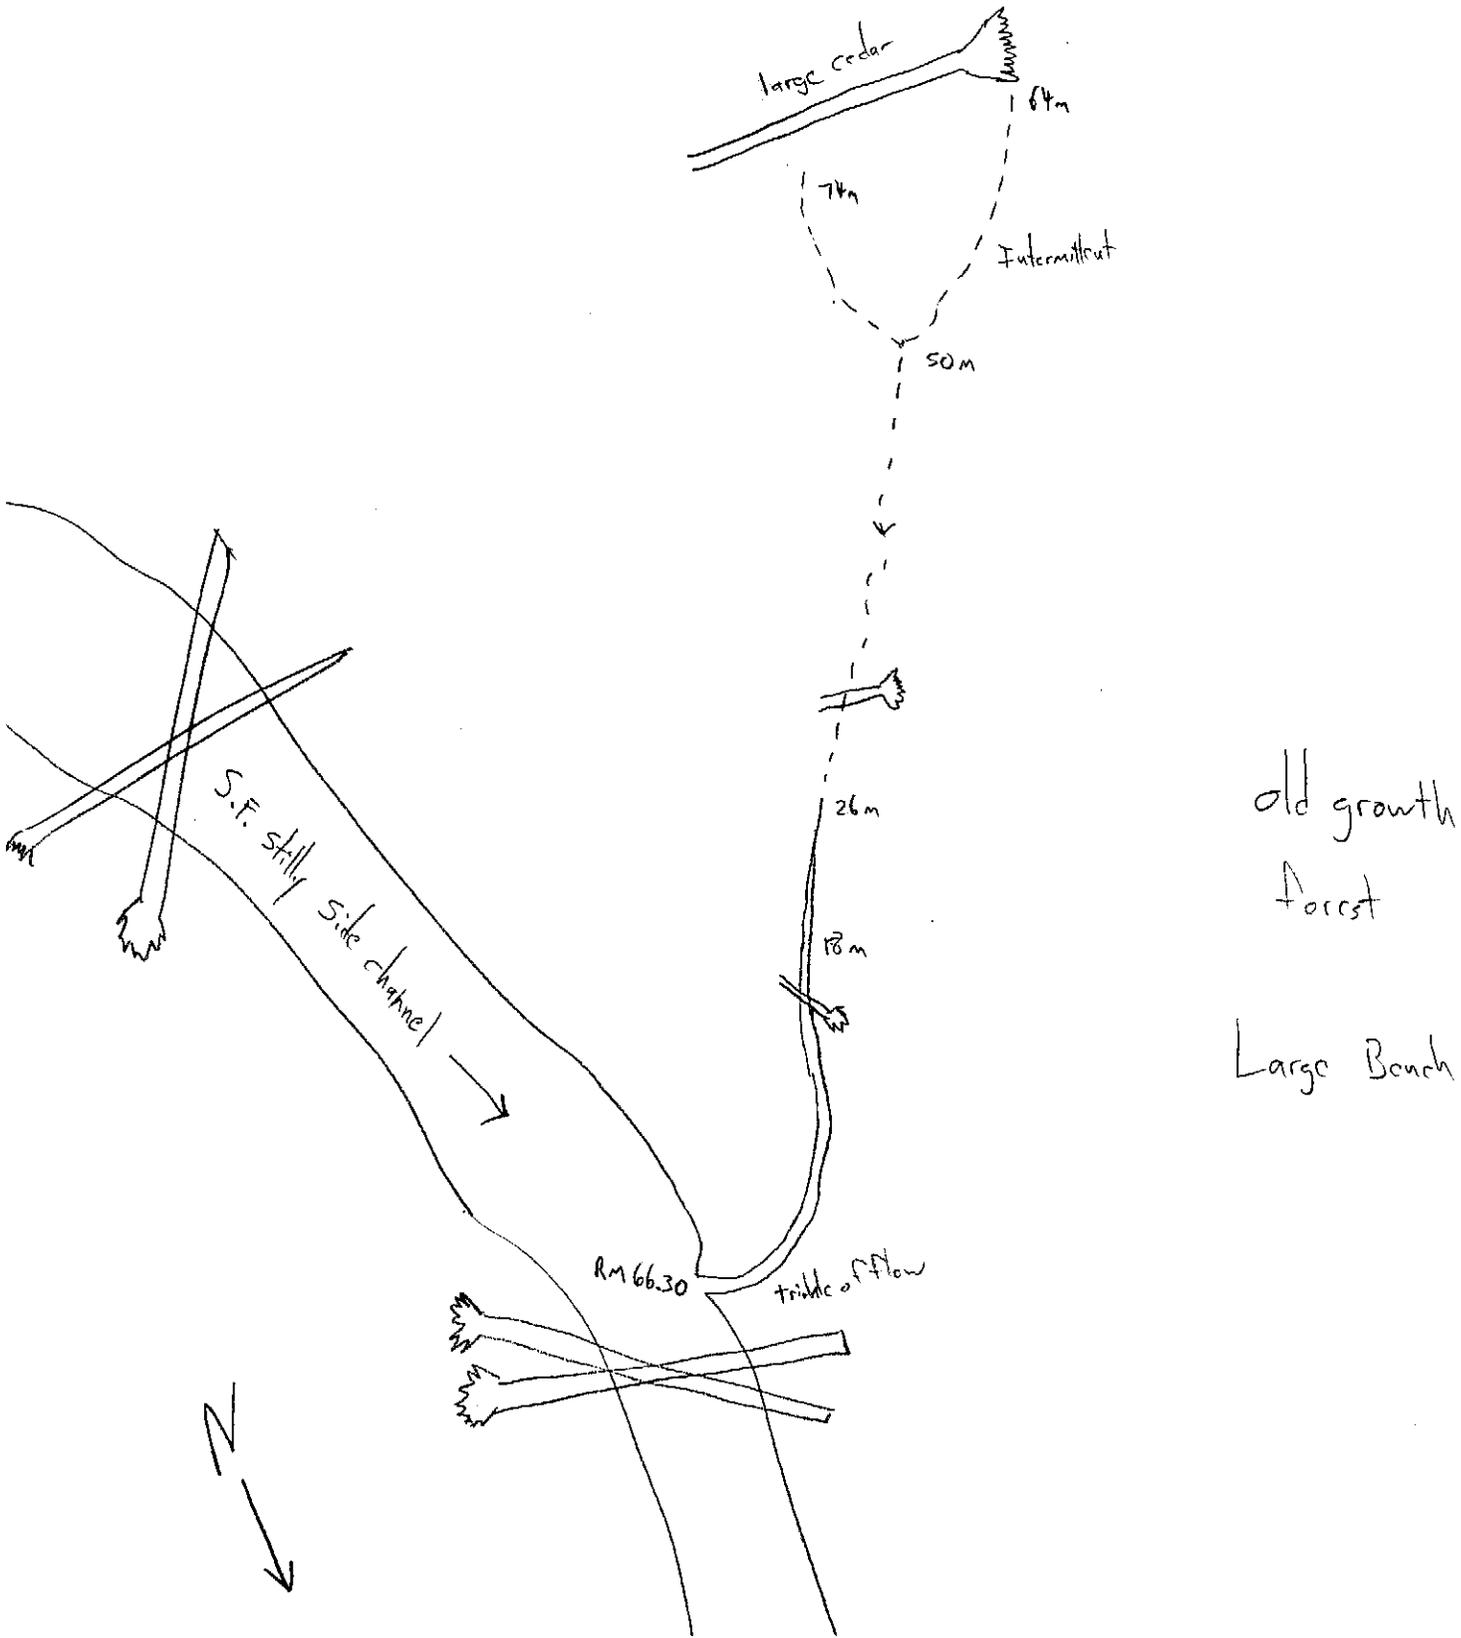
Site number: SS13LB8

10/21/02 LB tab to SE in log for Sec
0 track of flow 50° 5m deep into sec
15 1.8 gvc many pots, large logs, Fish
thick Brush - St Current, PC, S, B
26 1.5 end of flow
50 2.5 channel splits mud bottom
64 2.0 LB ch. Ends
74 1.5 PB ch. Ends

lots of log SSBLB8
Oldgrowth forest

no spawing
width 25m

total Area $24.4 + 12 + 60 + 12 + 15 = 124$
