Site name: SUIRBI

Observer(s): MICHAEL OLIS

Legal location: NW 1/4 S15 T33N R10E

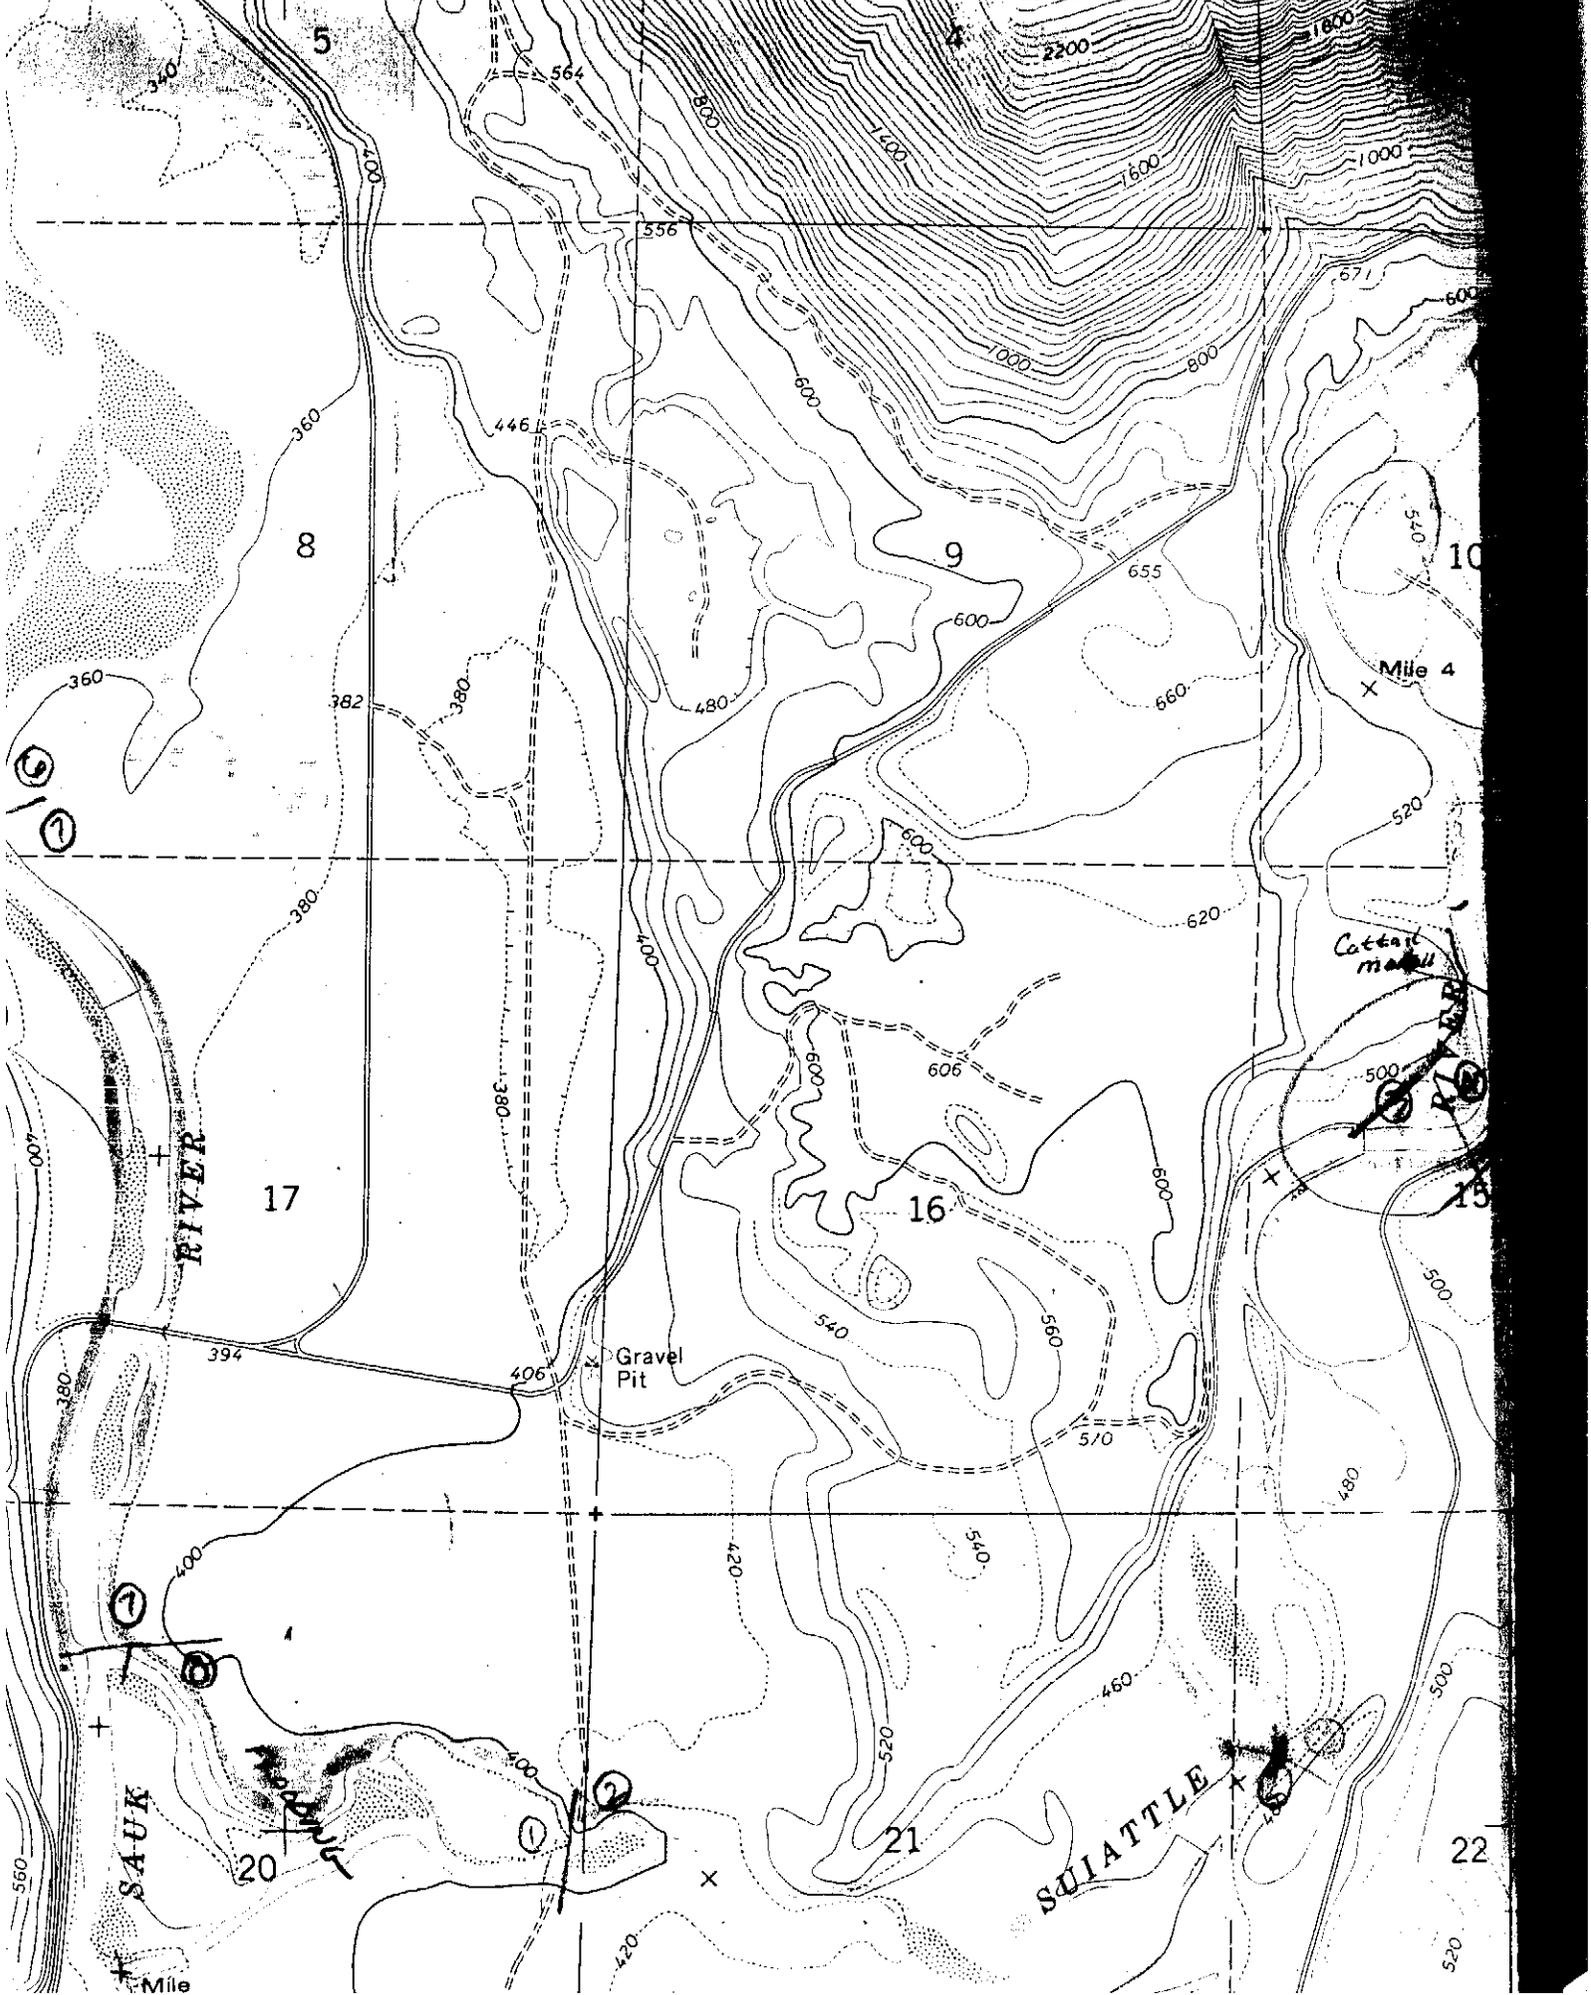
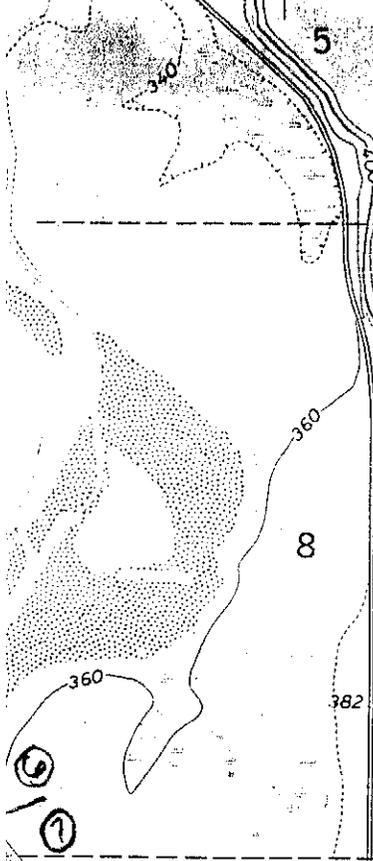
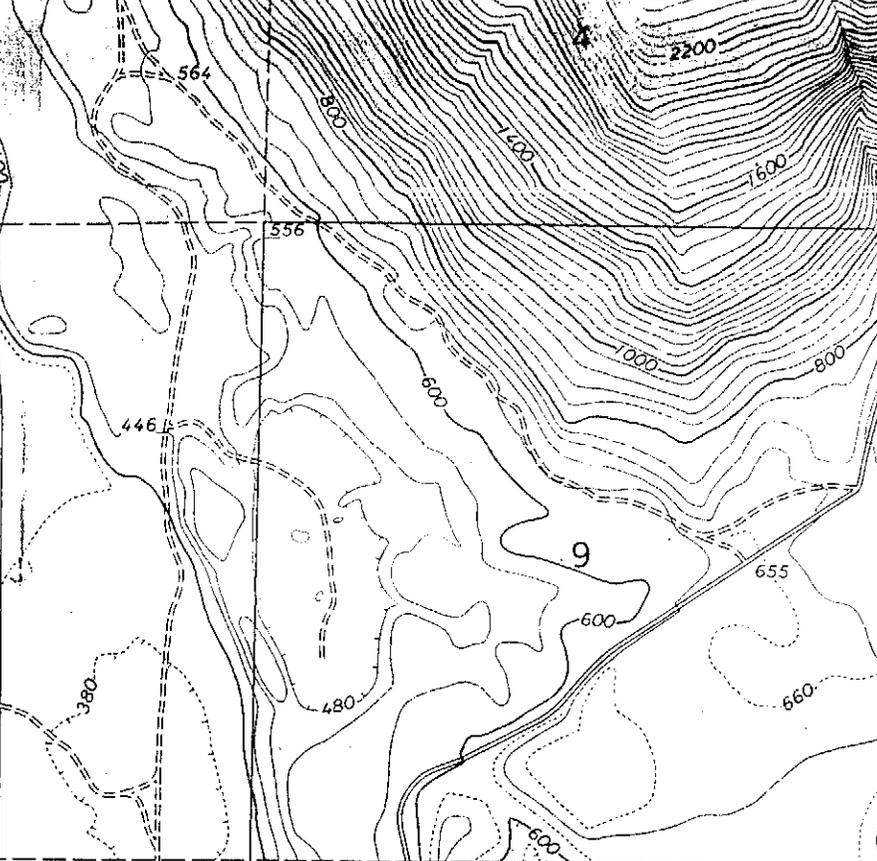
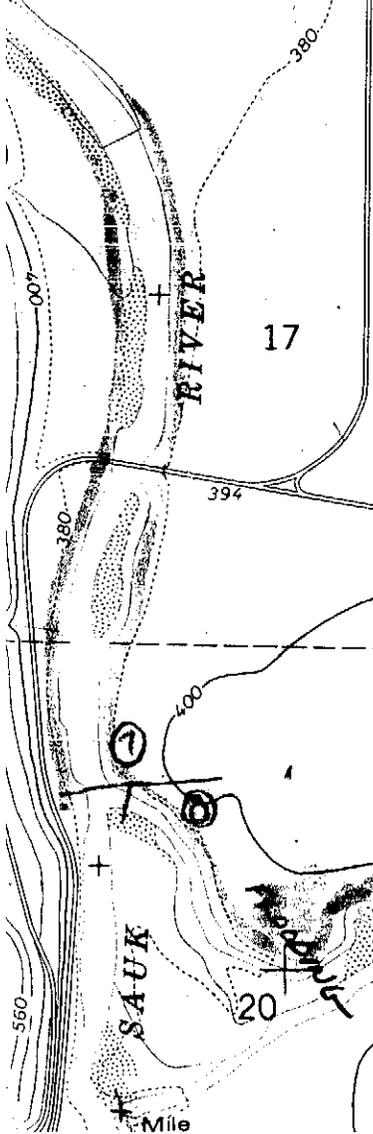
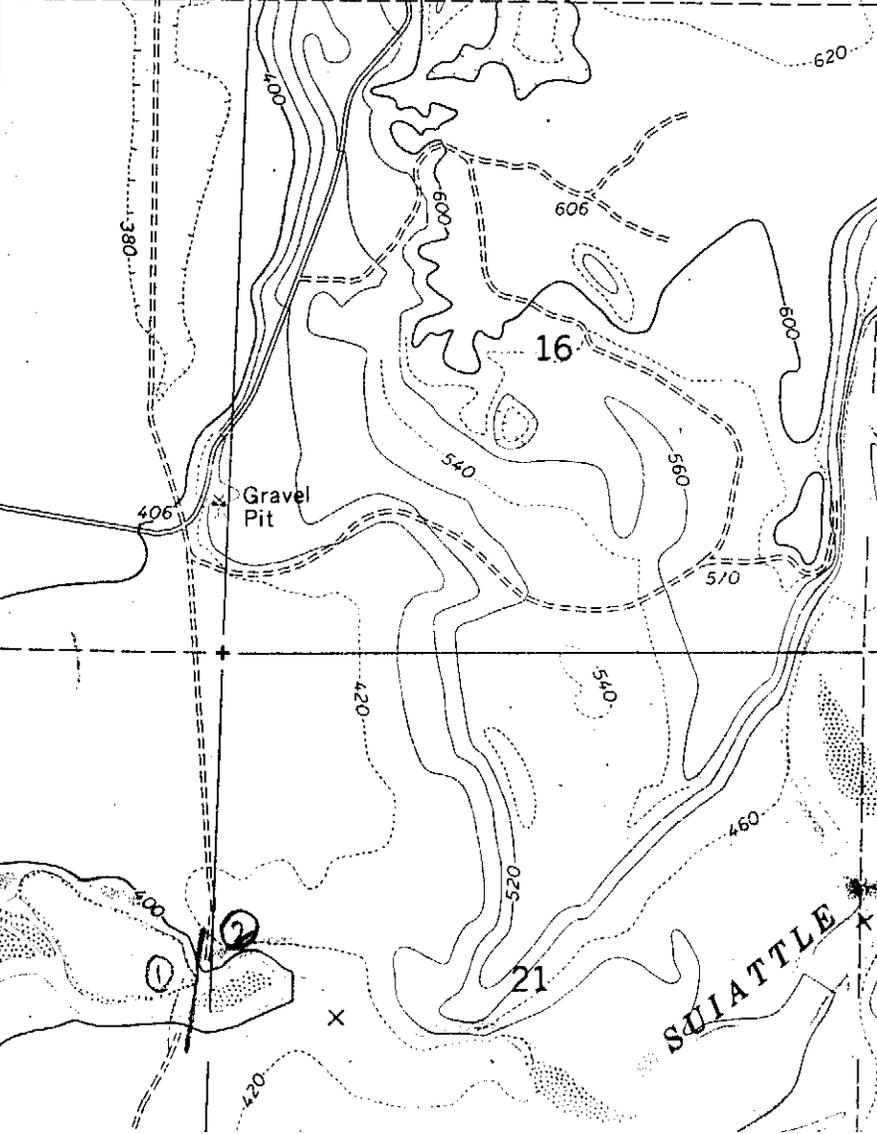
- STRM TEMP - 43°
- REC WTR TEMP - 40°
- FLOW 0.25 CFS
- NO ACCESS - 6 FOOT DROP TO RIVER
- 34m WW 1m
- SLOW MOVING; MOSTLY POOL
- SILTED SUBSTRATE
- HORSETAIL, BERRY BRUSH ALONG BANKS
- 75m WW 2.5m POOL
- LEAVES ON MUCK FOR SUBSTRATE
- @ 4m BVR DATA

116m WW 4m POOL
- @ WIPED OUT BVR DAM

138m WW 4m POOL
- SOME WTR PARALLEL
- ALL SWAMP CHANNELS
- WTR

173m WW 3m POOL

- @ 6m BVR DAM

- SMALL AMOUNTS OF RIVER WTR ENTERED STRM. (DURING NOV. FLOOD)
JUST BELOW BVR DAM
- SWALE BANK ON BOTH SIDES, AHEAD

311m WW 8m POOL

477m WW 7m POOL

- WTR ENDS - TEMP 44°

- NO SPAWN HAB.

- FLOOD EVENT CUT AWAY ANY ACCESS @ MOUTH

- EXCELLENT REAROLG

- HABITAT - LOTS OF STRUCTURE

- OLD RIVER SWALE THAT

BVRS DAMMED UP,
