**SITE INFORMATION**

**Site Identifier :** SU2RB2 **Landowner Type :** Federal  
**Site Name :** **Landowner Name :** USFS  
**WRIA :** 03.0710X **Address :**  
**Region :** NS **Address2 :**  
**Trib to :** Suiattle R **City :**  
**River Mile :** 7.00 **State :**  
**River System :** Suiattle R **Zipcode :**  
**Legal Description :** NW1/4S13T33NR10E **Phone :**  
**County :** Skagit  
**Habitat Type :**

**Field Survey Information**

**Date :** 12/20/1995 **Observer :** Olis **Survey Type :** initial

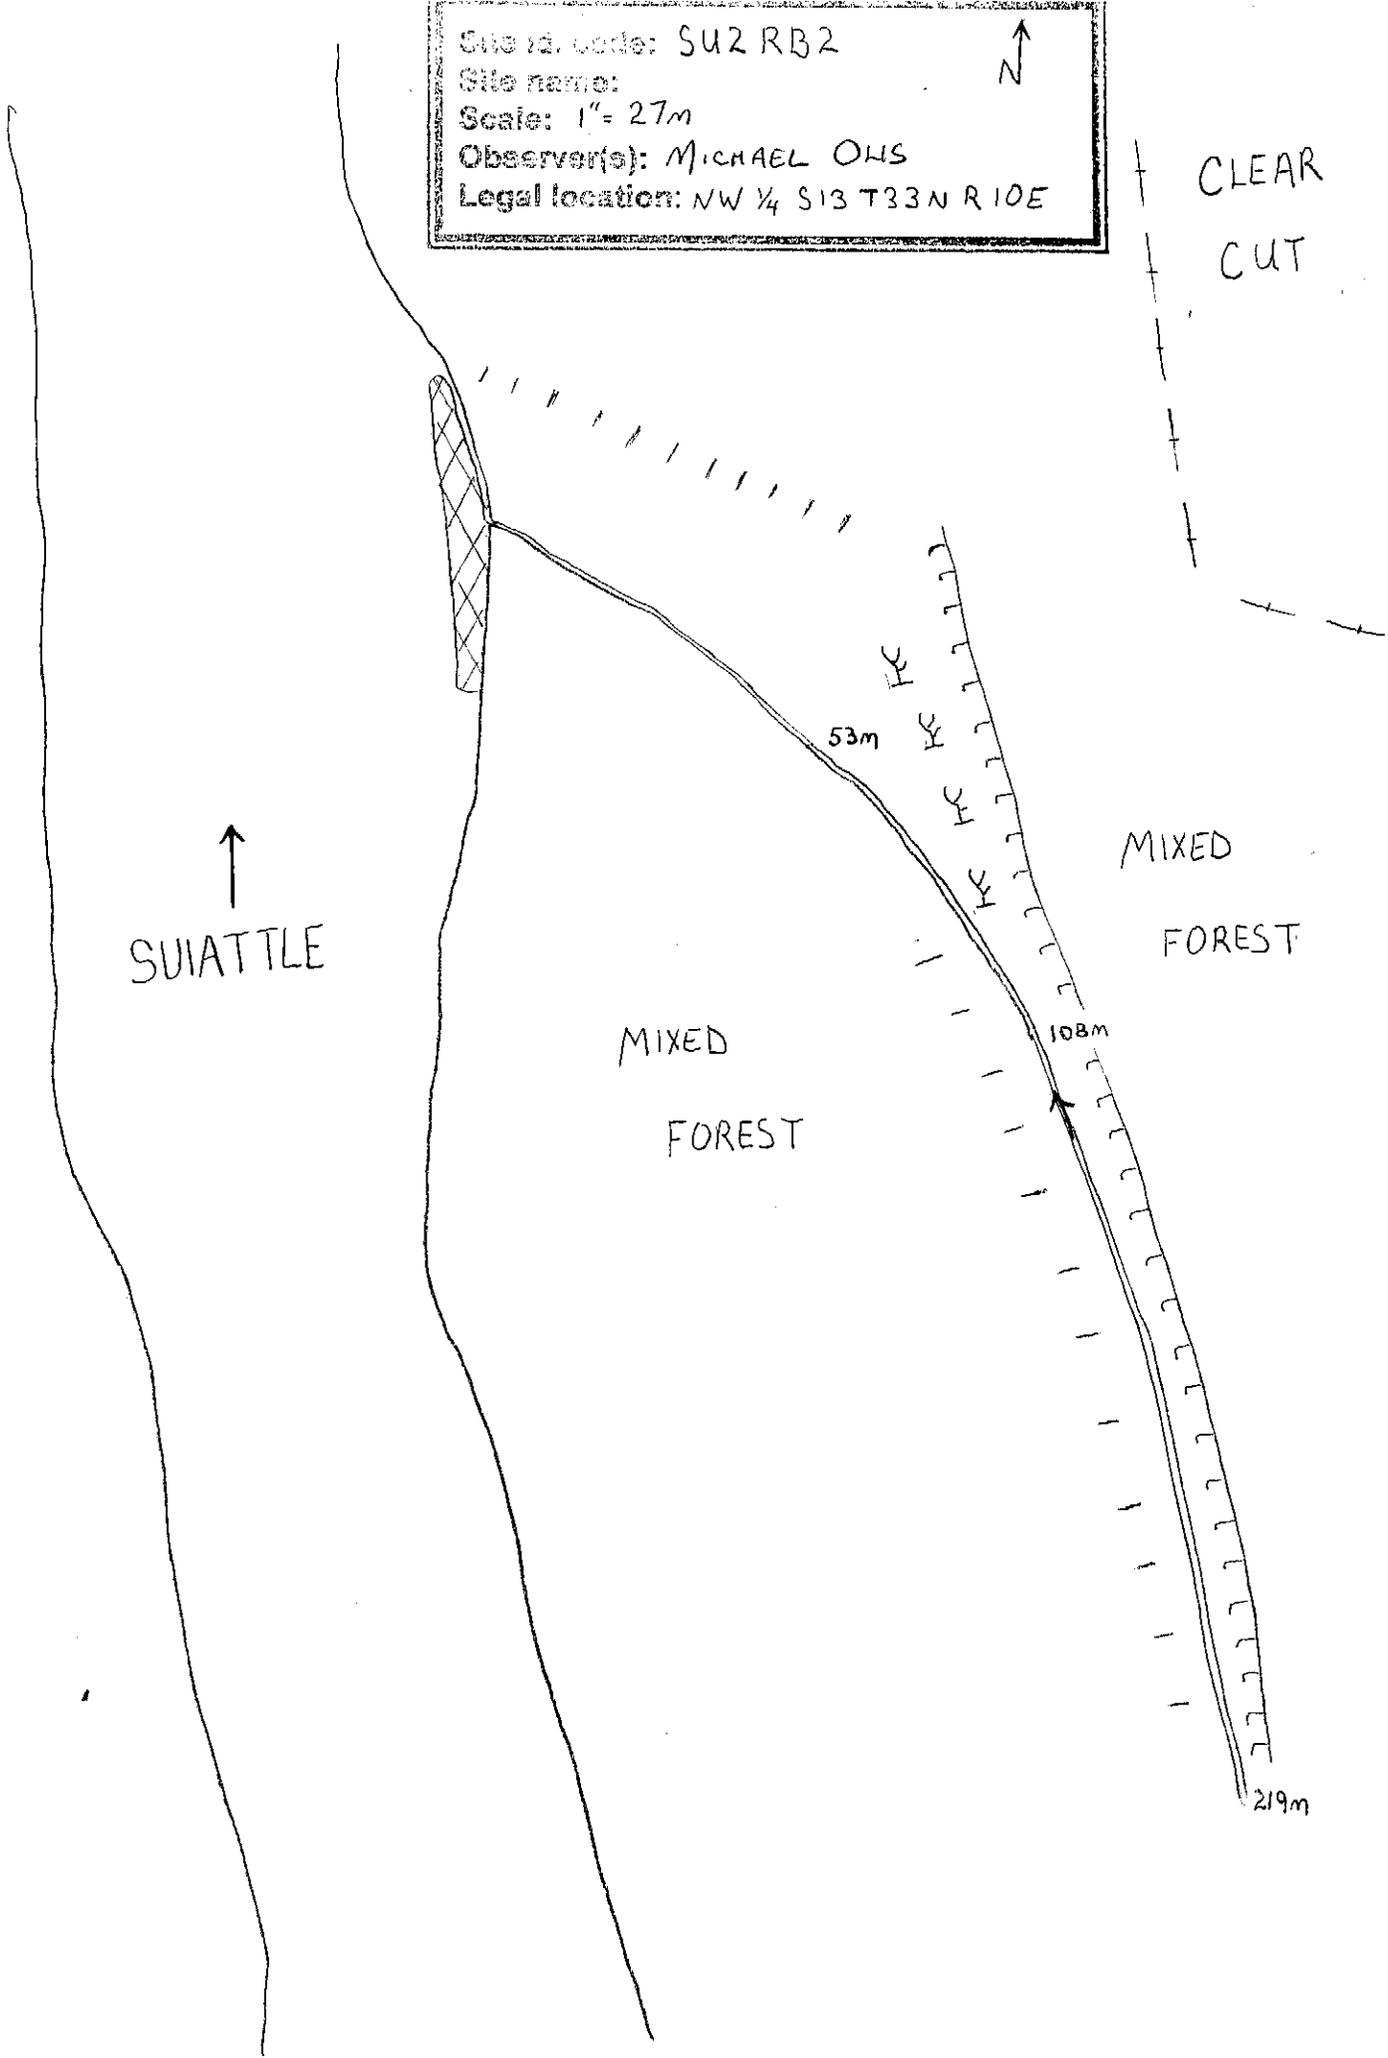
Site id. code: SU2RB2

CLEAR  
CUT

↑  
SUIATTLE

MIXED  
FOREST

53m

108m

219m

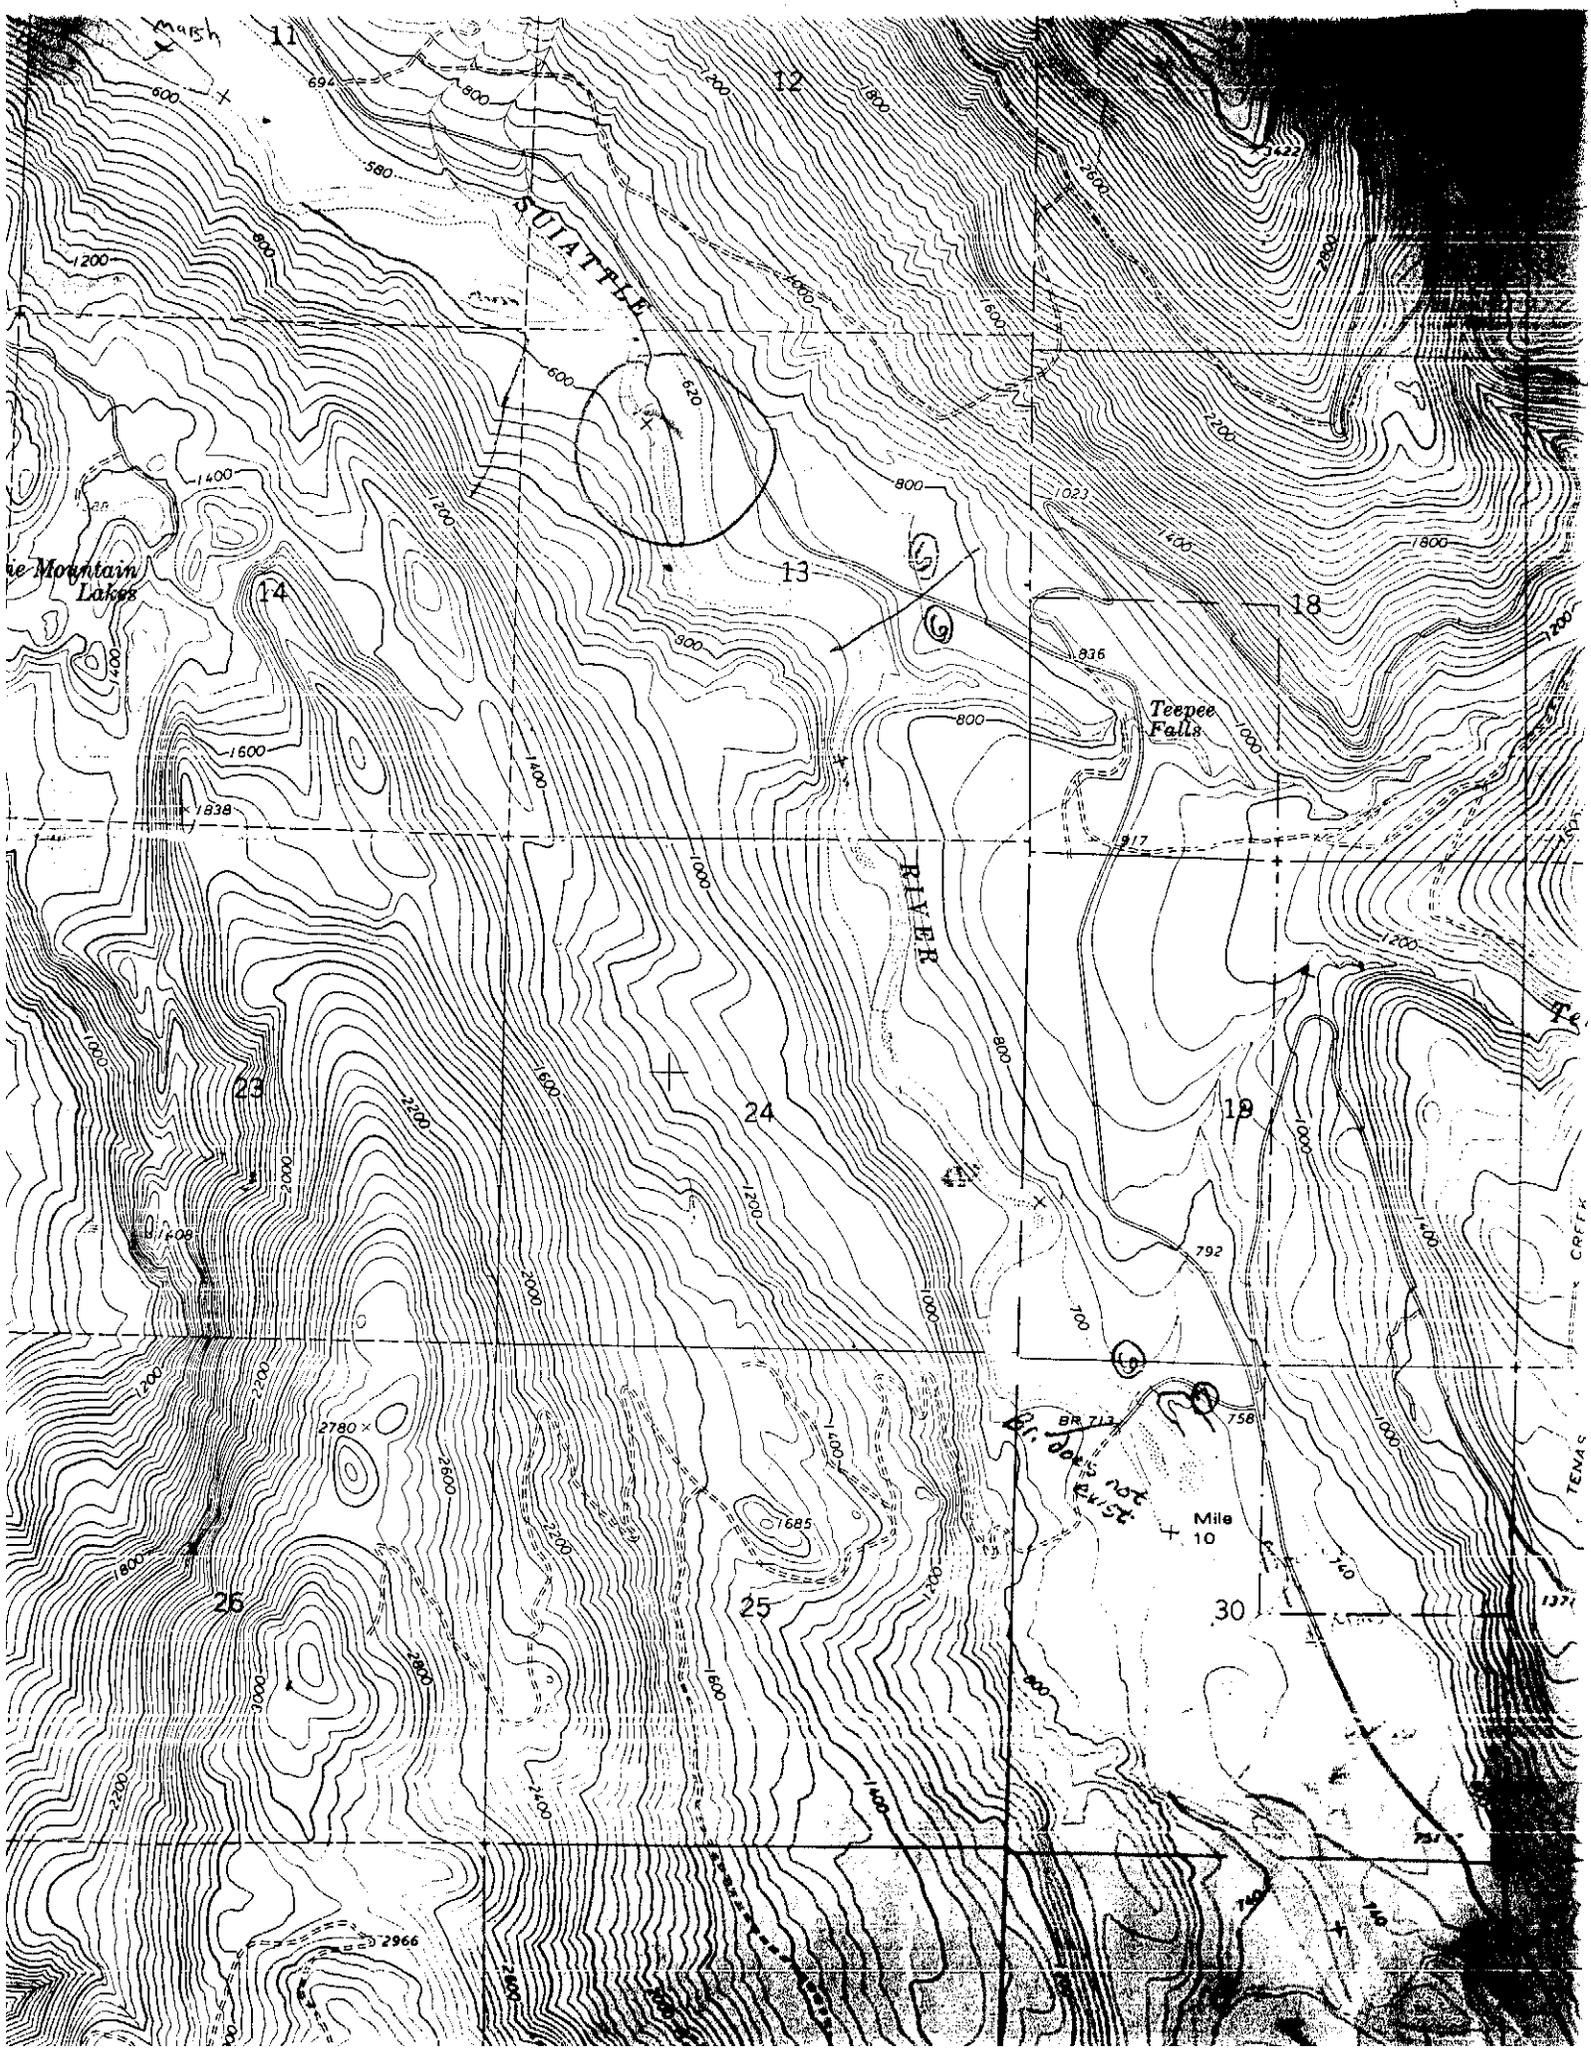
SUZ RB2

O.F. ENTRY

- REC W TEMP - 41°

- STRM TEMP - 45°

- FLOW 0.1 CFS

- NO ADULT ACCESS &  
JUV. ACCESS IS MARG.

BECAUSE STRM HAS  
TO NEGOTIATE THROUGH

RIVER SILT RECENTLY  
DEPOSITED BY FLOOD

53M WW 1M

- SHALLOW (2"-4"), SLOW  
MOVING STRM.

- BOTTOM HAS LEAVES  
& IS MUD & SILT MIX

- HEAVY W/ BERRY BRUSH

- AQUATIC VEG. IN WATER

108m WW 1m

- @ TOE OF HILL &  
STRM STARTS TO  
PARALLEL IT.

219m WW 1m

- STRM COVERED @  
TIMES W/ FALLEN TREES  
& BRANCHES  
END OF STRM TEMPLE

WALL GASE STRM THAT  
OFFERS SMALL AMOUNTS  
OF REARING

- GRND WATER SOURCE
- NO SPAWNING
- SEEMED NOT TO BE  
BOTHERED BY FLOOD...

... EXCEPT @ ENTRY

- NO FISH SEEN
- UNSURE IF IT DRIES  
UP DURING SUMMER
