SITE INFORMATION

Site Identifier : SU5RB6 **Landowner Type :** Federal
Site Name : **Landowner Name :** USFS
WRIA : 03.0710NX **Address :**
Region : NS **Address2 :**
Trib to : 03.0710N **City :**
River Mile : 0.10 **State :**
River System : Suiattle R **Zipcode :**
Legal Description : SE1/4S10T32NR11E **Phone :**
County : Snohomish
Habitat Type : off-channel pond

Field Survey Information

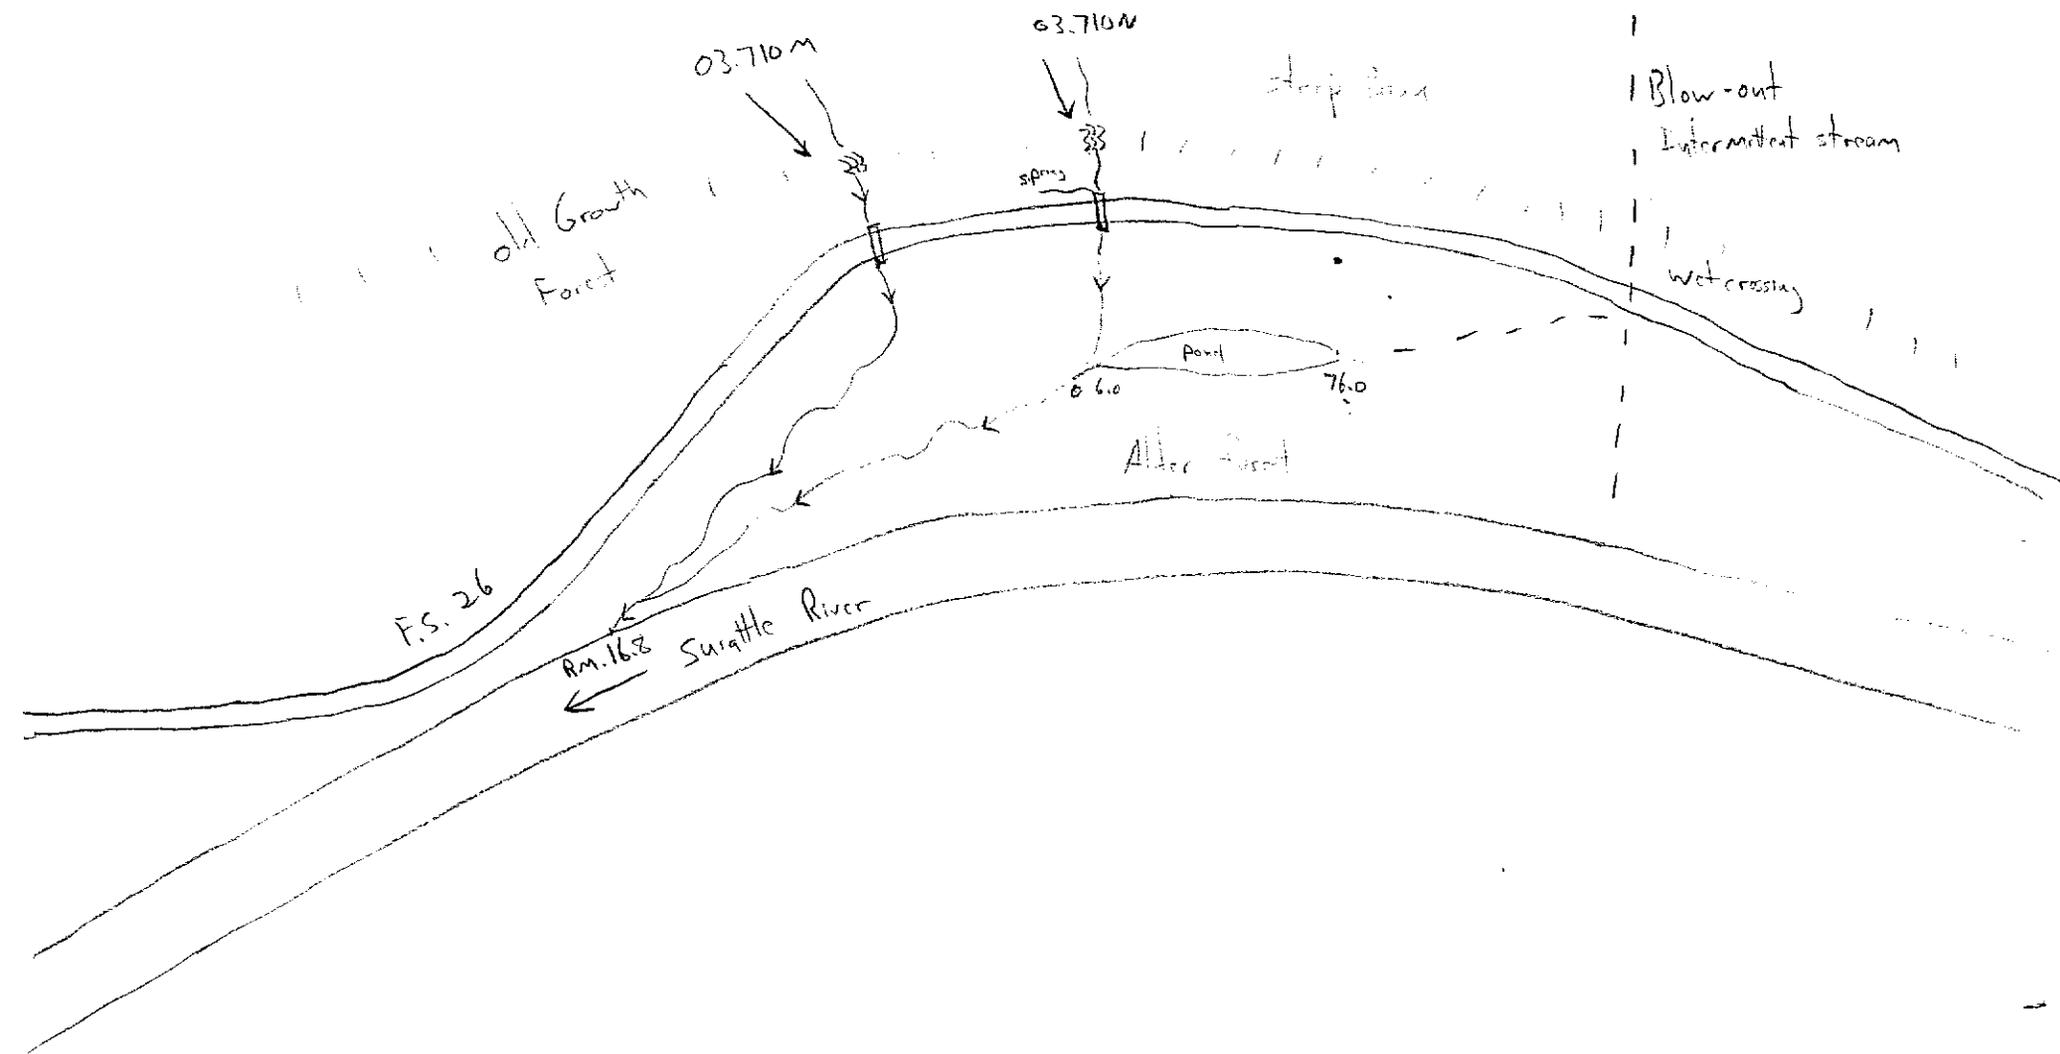
Site id. code: S45 RB6

Describe pond and other rearing habitat: Pond is shallow and seasonal with little cover. Site only flows during rain storms.

Scale: 1" = 65 meters

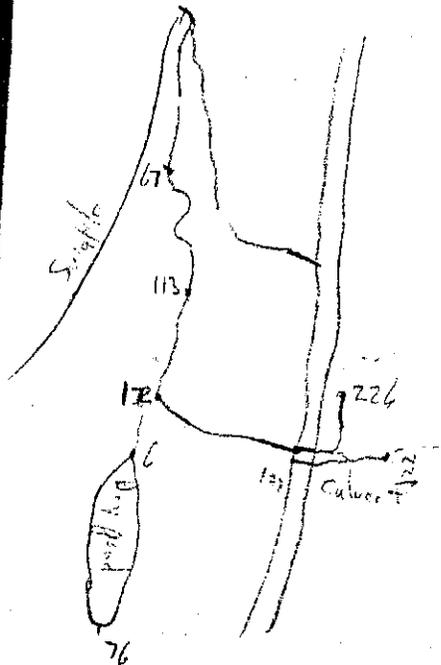
SU5 RB6

- DOWN
- 611 as trib to cr Above slou
- 61.0 2' wide
 - 67.7 3' wide ave, 99% pool, 50% gravel
start of gravel
 - 112.9 3' ave End of major gravel
75%/25% pool
 - 145.0 3' ave 50% bottom 99% pool
 - 172.0 2' ave 99% pool, road cut
 - 197.0 2' ave 85/15% some gravel
 - 210.0 end of culvert
 - 214.0 ch. splits 5' wide
 - 221.0 3' End of ^{LB} culvert Rode observed
 - 226.0 2'

Very large #s of Coho
 and some Smolts throughout
 fish got pool with high flows
 were also trapped
