SITE INFORMATION

Site Identifier : SU7RB3 **Landowner Type :** Federal
Site Name : Cutoff creek **Landowner Name :** USFS
WRIA : 03.0710X **Address :**
Region : NS **Address2 :**
Trib to : Suiattle R **City :**
River Mile : 24.90 **State :**
River System : Suiattle R **Zipcode :**
Legal Description : NW1/4S23T32NR12E **Phone :**
County : Snohomish
Habitat Type : overflow channel

This site is an old Suiattle side channel that has been cut off by a log jam at the upper end. It provides a small amount of fair habitat for rearing, mainly in the lower end where it is of lower grade.

Date : 08/24/1995 **Observer :** Barkdull **Survey Type :** initial

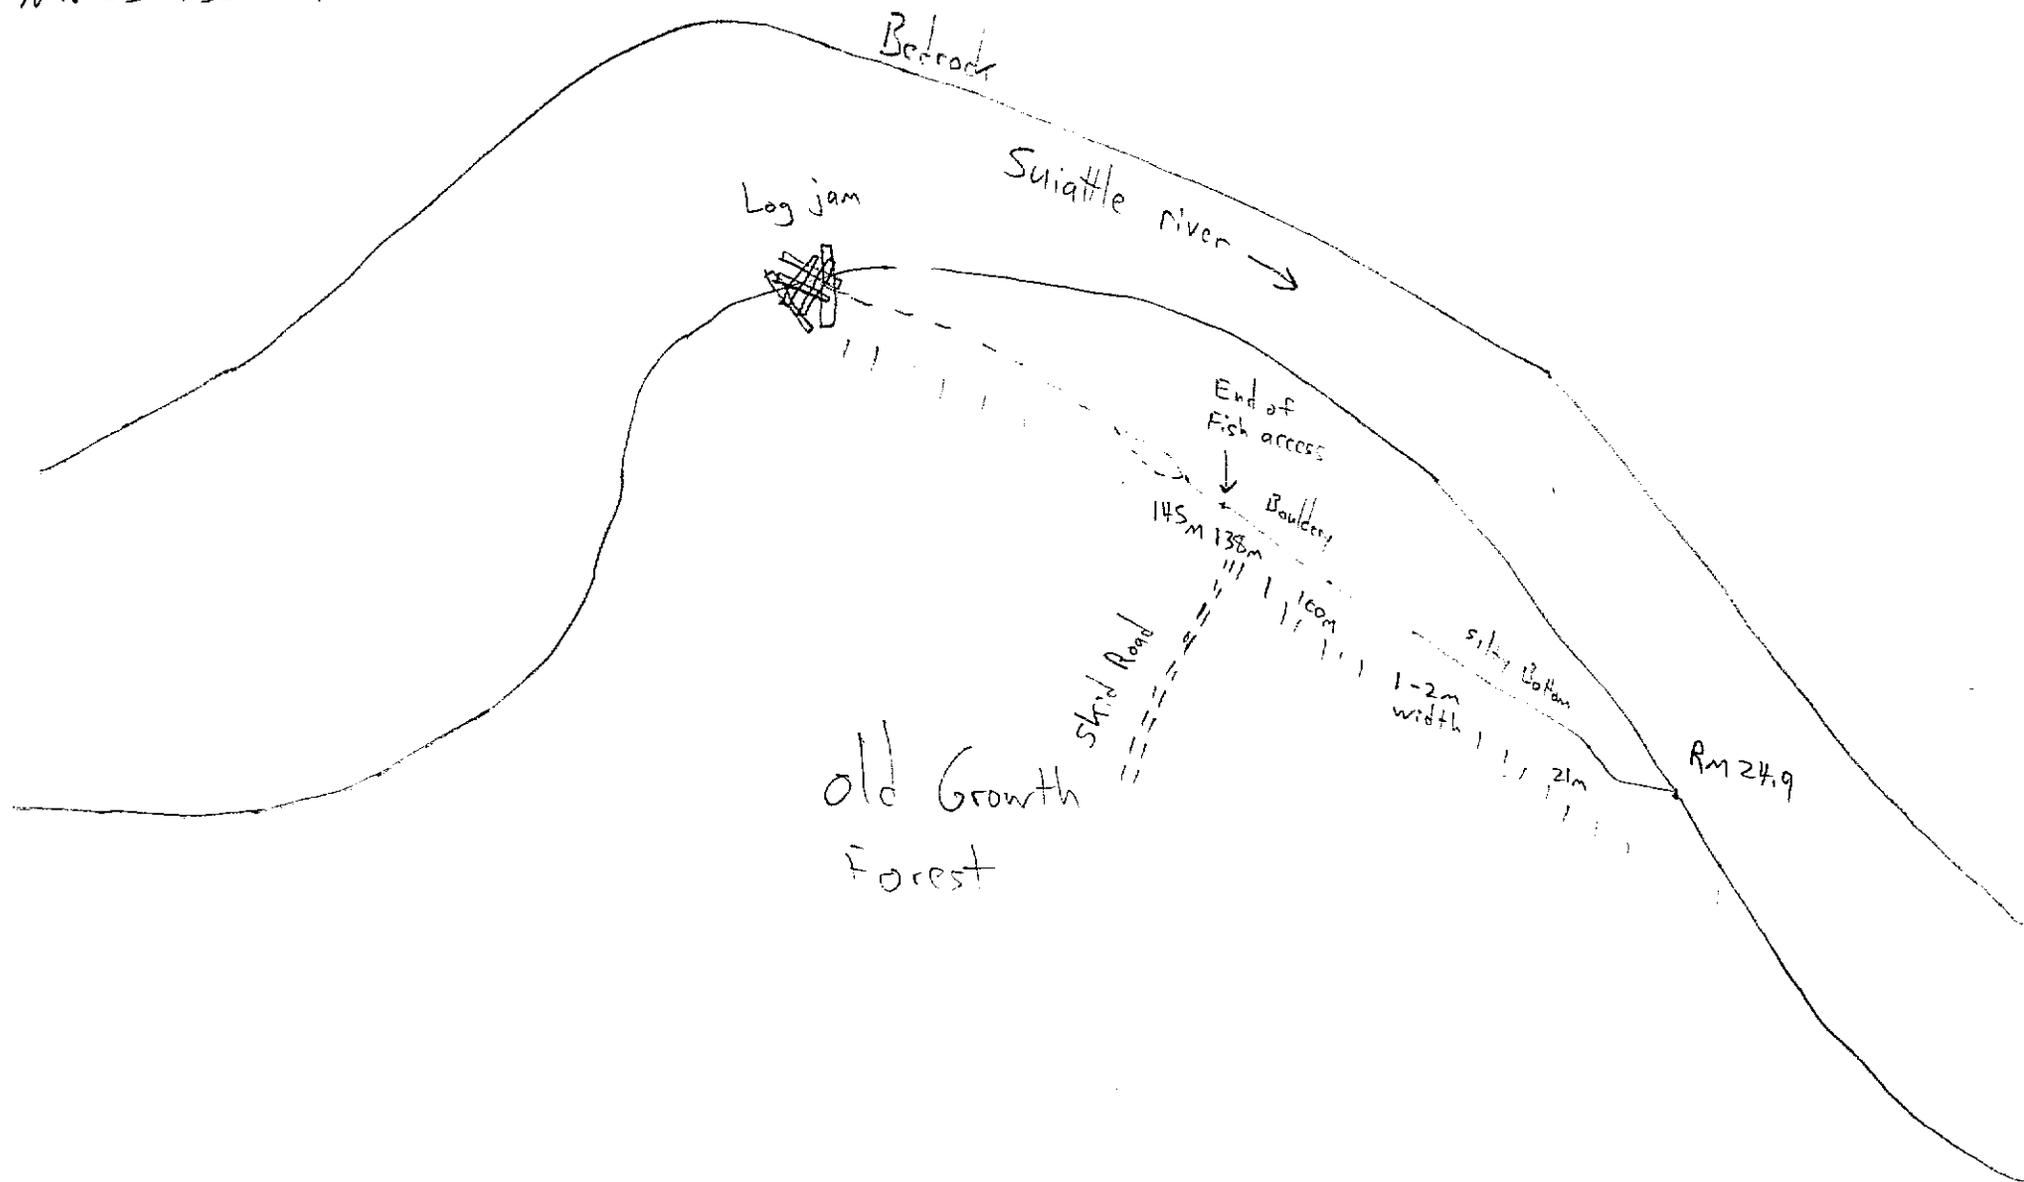
SU 1 R B 3

Scale 1" = 50 meters

NW 23 T32N R12E

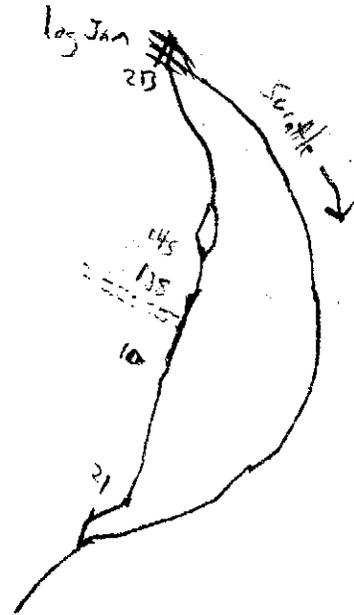
Su 7 RB3

010	1m wide	silty	0.02 cfs
210	0.5	silt bottom	
160	2.0	start of Boulders	
138	1.5	end of fish arcs	
145	1.0	end of possible winter Ave	
213		puddles of water to log jam

Many fish in channel 15 yr
trees along edge of channel
Somewhat flood protected by
log jam this is probably the
f.s. project not the one
mapped on 8-24/95
