SITE INFORMATION

Site Identifier : SU8LB1 **Landowner Type :** Federal
Site Name : **Landowner Name :** USFS
WRIA : 03.0710X **Address :**
Region : NS **Address2 :**
Trib to : Suiattle R **City :**
River Mile : 28.10 **State :**
River System : Suiattle R **Zipcode :**
Legal Description : NE1/4S36T32NR13E **Phone :**
County : Snohomish
Habitat Type : lower valley wall tributary

Field Survey Information

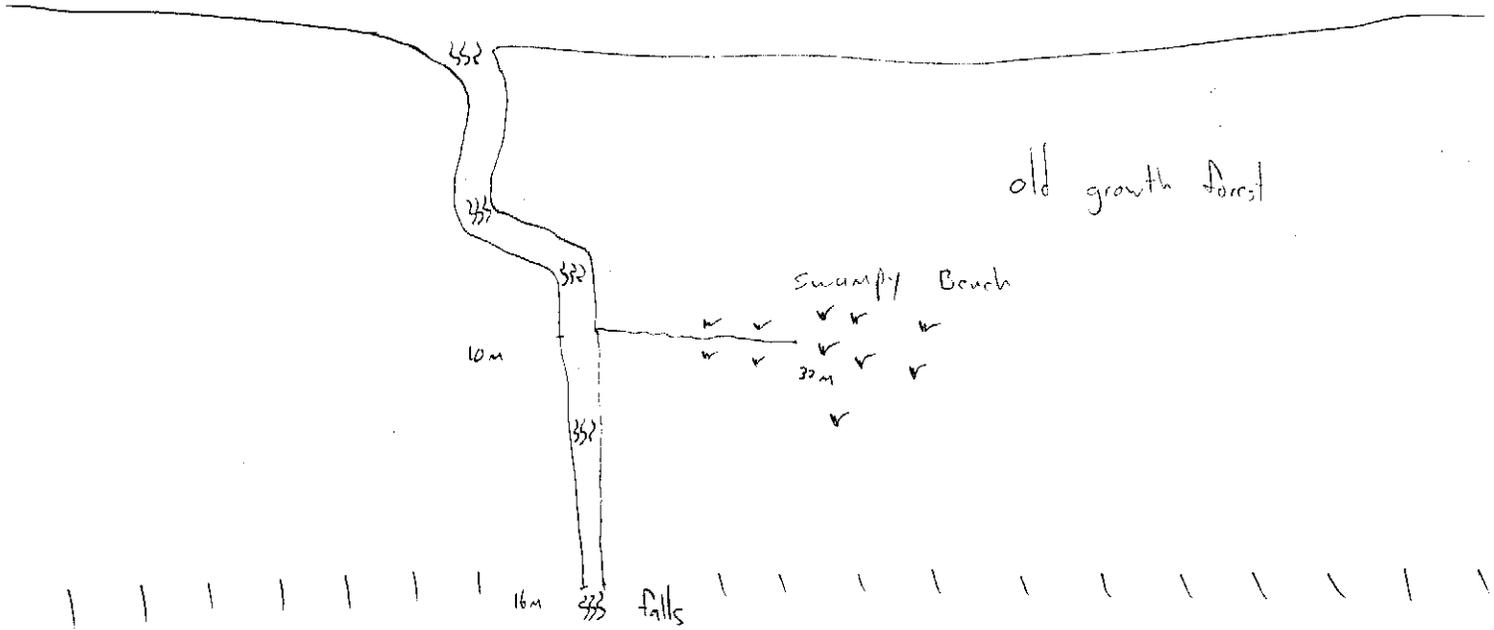
← Suiattle river

Rm 28.1

old growth forest

Swampy Bank

20m

Steep Mountain

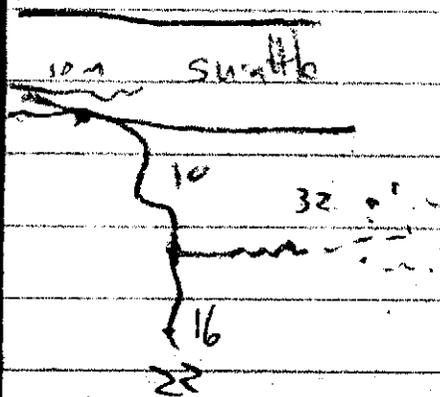
3/27/97 LD tub below miller

00	2.0	more sp gravel	48°
10	1.0	4/2 split ch	0.8 off
16	0.5	75% of flow end at	
		valley wall	
16	0.2		
32	0.1	no more access	
		spring fed	48°

River 50°

Rm 28.1

15+4 = 19

sp. 10

tub 1.6
