SITE INFORMATION

Site Identifier : SU8LB2 **Landowner Type :** Federal
Site Name : **Landowner Name :** USFS
WRIA : 03.0710X **Address :**
Region : NS **Address2 :**
Trib to : Suiattle R **City :**
River Mile : 28.20 **State :**
River System : Suiattle R **Zipcode :**
Legal Description : NE1/4S36T32NR13E **Phone :**
County : Snohomish
Habitat Type : overflow channel

Site is an overflow channel fed by a small surface tributary and by groundwater. Site offers nice rearing habitat and good cover with an occasional patch of spawning gravel.

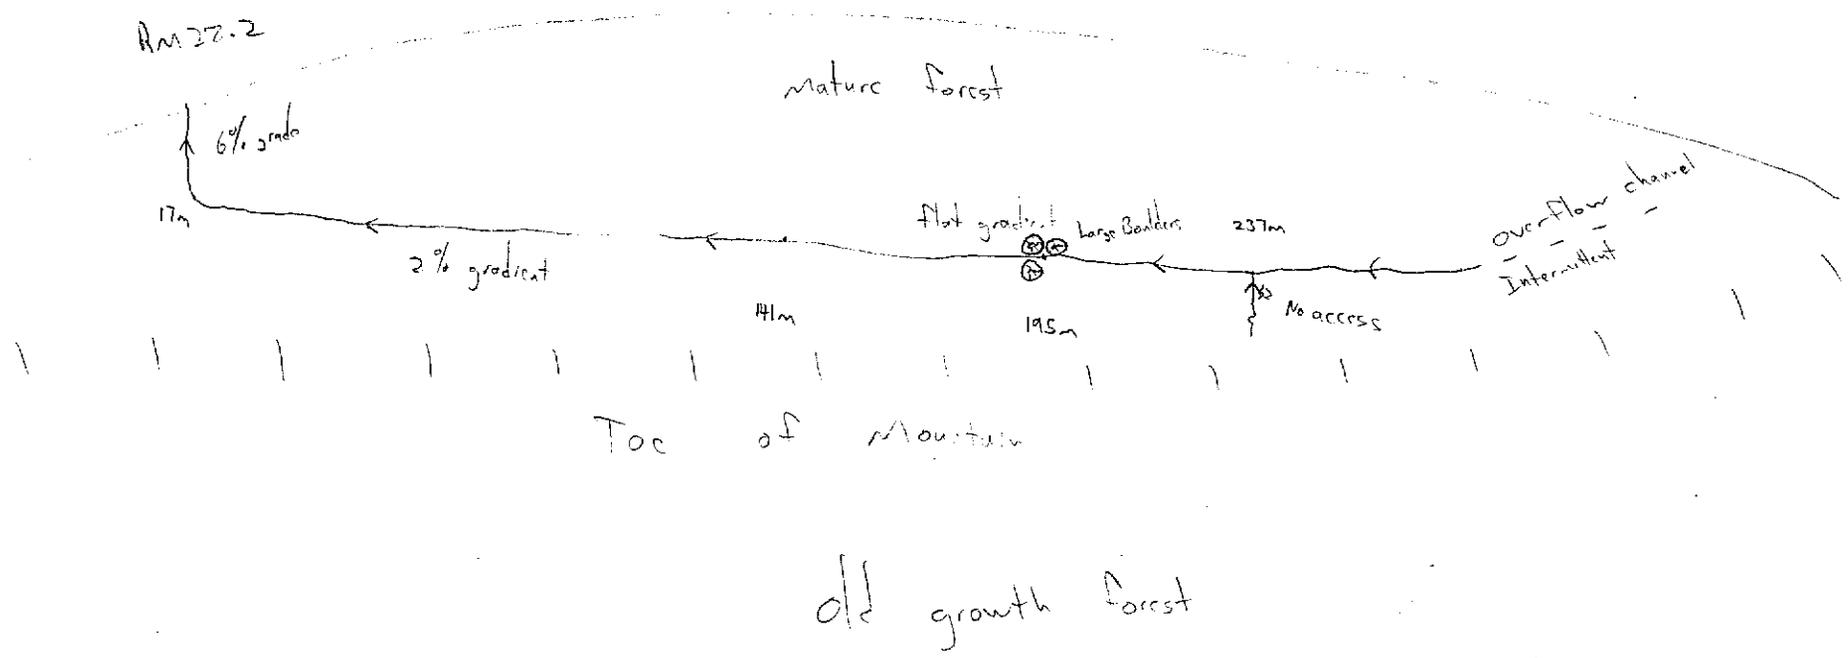
Site id. code: SU8LBZ
Site name:
Scale: 1" = 40 meters
Observer(s): B. Barkdull
Legal location: NE 36, T32N, R13E

← Suiattle River

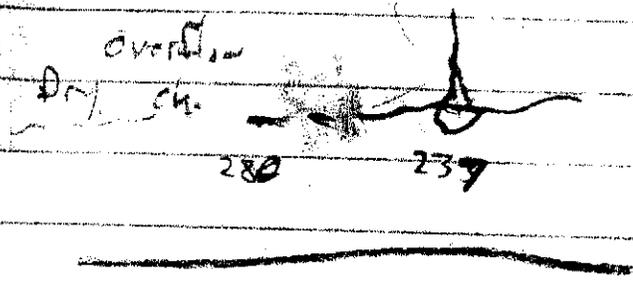
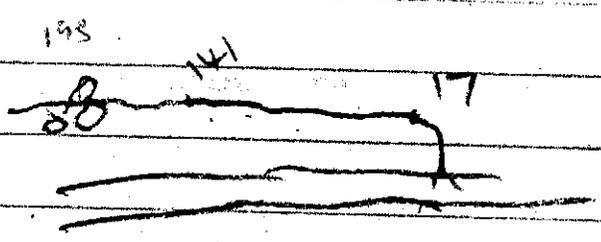
8/27/97 trip LIS to Swattle below
mill (next see previous pages)

0.0	1.0	0.5 cfs	48°
17	1.5	6% grade	2 gravel patches
141	1.5	2% sandy w/ boulders	2 patches gravel
198	2.6	low gr	3 large boulders
205	1.5	front Rock?	
237	1.5	Crack off of Hill	
280	1.0	Intermittent
