SITE NUMBER: WD-R3-02

NORTH COAST OFF CHANNEL SITE INVENTORY DATA

RIVER SYSTEM: W.F. Dickey **DATE:** 5/5/93 **OBSERVER:** Powell, Nettin

RIVER: W.F. DICKEY
AREA: WD-R3
SITE: WD-R3-2
NAME:
DATE: 5/93

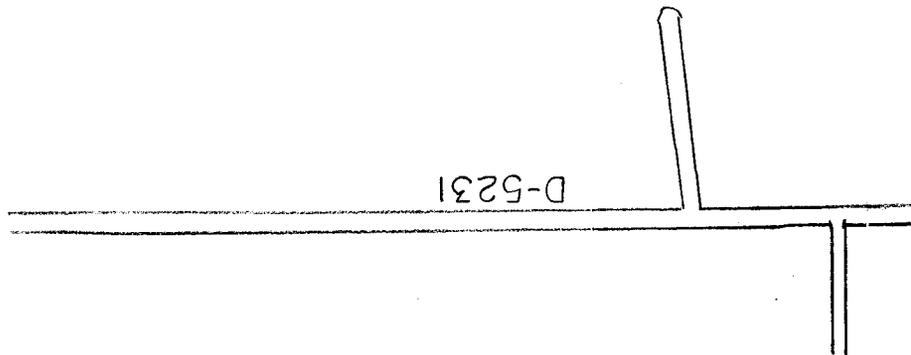
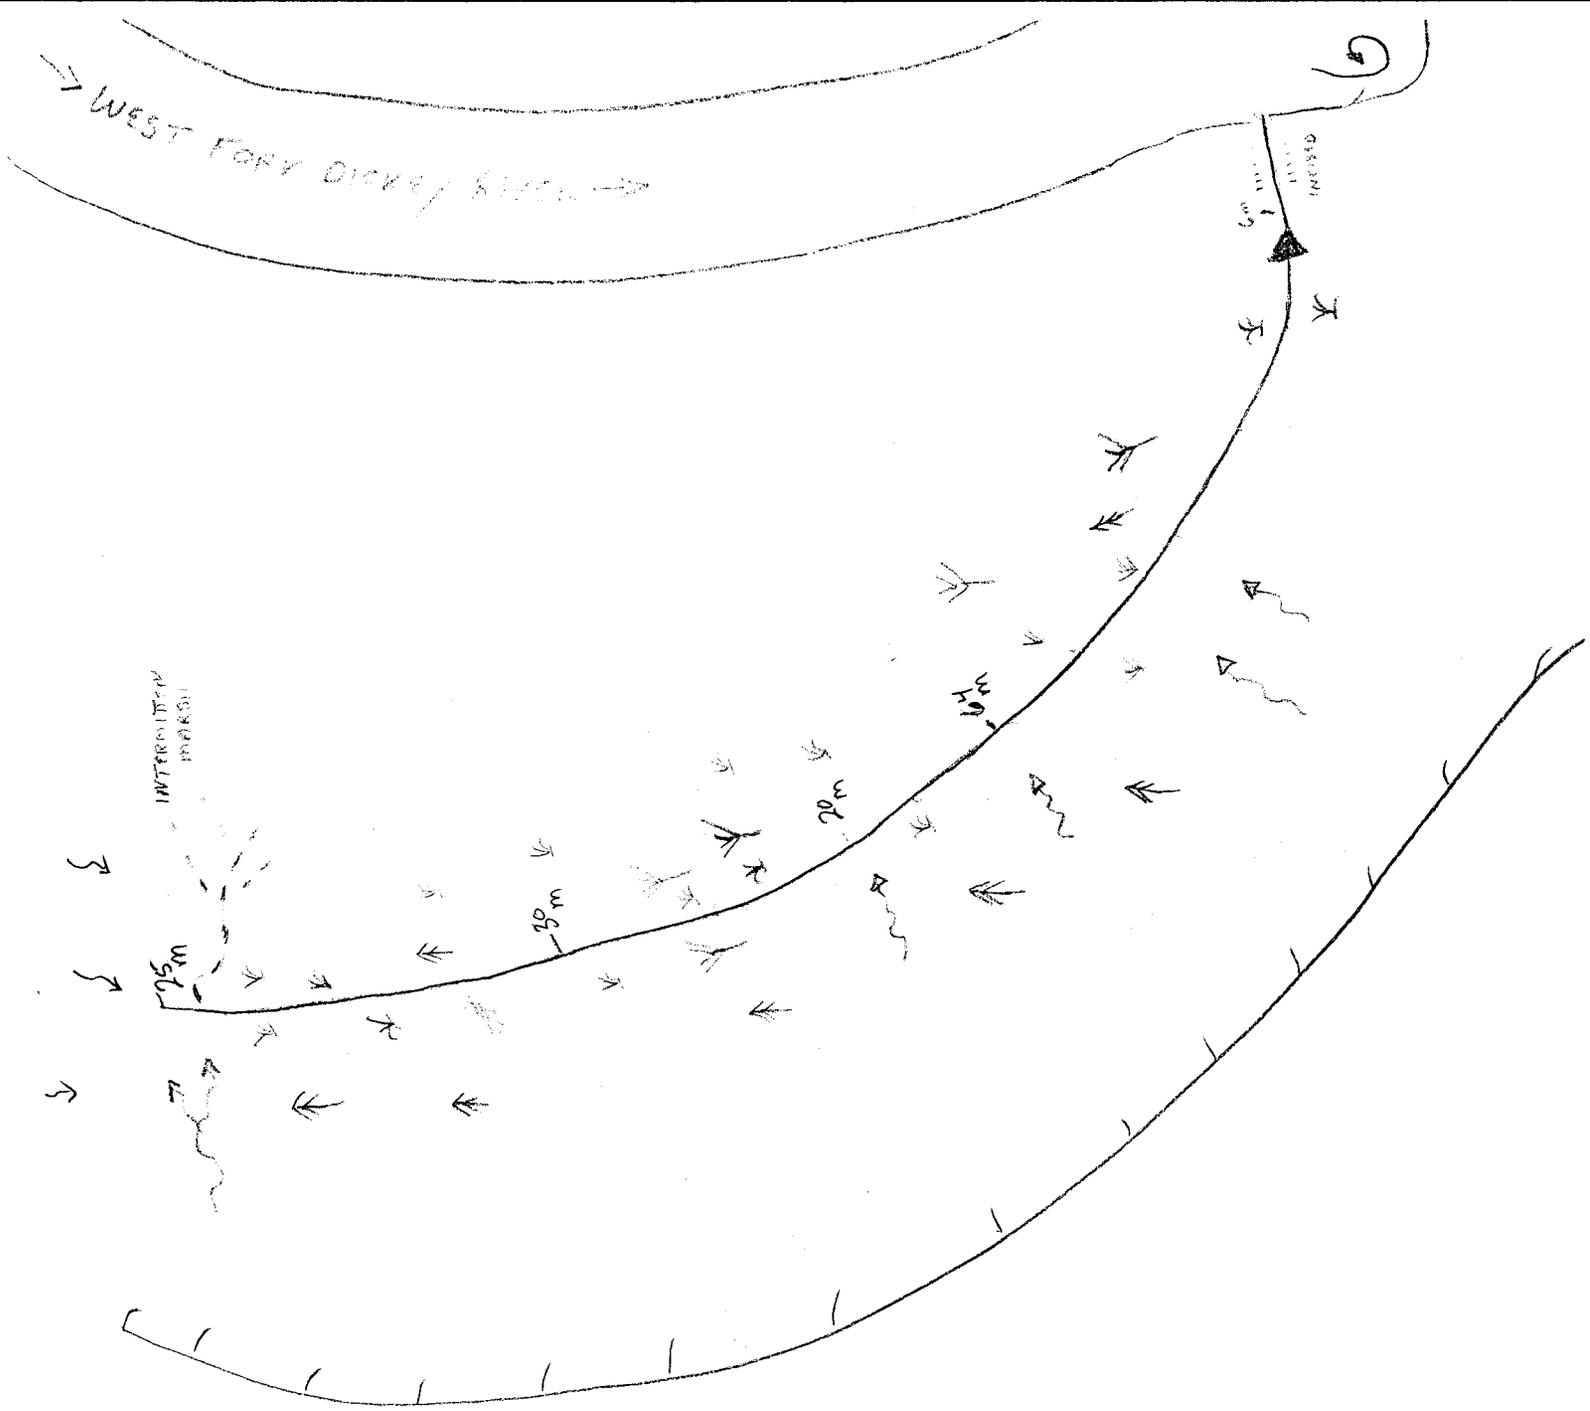
SITE SIZE: Length- 145 m
Width- Water surface = .5 - 1 m
Channel = .5 - 2 m Marsh = 3 - 15 m
Depth- 3 - 10 cm Max- 15 cm

- Stable marsh lands above 4 m.
- A gentle gradient.
- Lower reach is covered with wood debris, small conifers, and sedges.
- Upper reach is covered by alders, wood debris, small conifers, and sedges.
- Marsh ends ~145 m into an area of intermittent standing water.
- This stretch of river is lacking in habitat.

- Due to stability of marshlands and lack of habitat in area, a beaded channel is suggested.
- Maintain the integrity of the stream.
