COWLITZ WILDLIFE AREA

2014 MANAGEMENT PLAN UPDATE

Washington Department of Fish and Wildlife

Land Management Summary

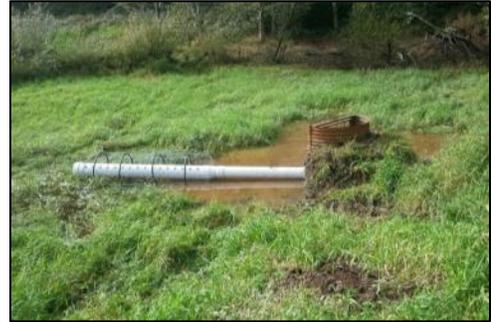
The Cowlitz Wildlife Area (CWA) has taken a new approach to dealing with the beaver issues that have plagued the Mossyrock Unit for years. These industrious builders have thwarted every effort to keep them from damming the ditches supplying the ponds with water as well as the standpipes that maintain the pond water levels. In 2013, CWA staff built and installed a version of the Clemson Pond Leveler on one of the ponds that has had the most beaver activity and have mowed the brush from the banks of the ditch. The leveler is submerged and is built such that water current is negligible if not non-existent. The pond level is controlled by the use of a standpipe. The standpipe is protected within the old water control structure so no matter how much debris the beaver piles around or in the standpipe the water flow will not be impeded.

Clemson Pond Leveler – Mossyrock

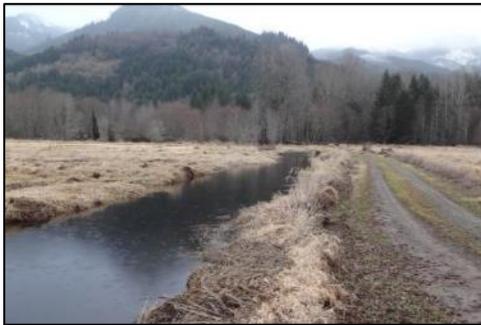
Kiona Unit Ditch -- Winter 2013 / 2014

This project restored 2,580 feet of drainage ditch to working order and replaced 2 plugged undersized culverts. Reed canarygrass, siltation, and sedimentation were preventing proper flow and causing impounding of the water within the ditch. The result of this impounding increased water levels that overflowed the banks of the ditches and flooded the adjacent agricultural fields. The flooding was persistent and prevented management of the fields for winter waterfowl and elk forage. Monitoring the project site during the winter of 2013 and 2014 (a very wet winter) showed shallow ponding within the fields and the ditches functioning properly.

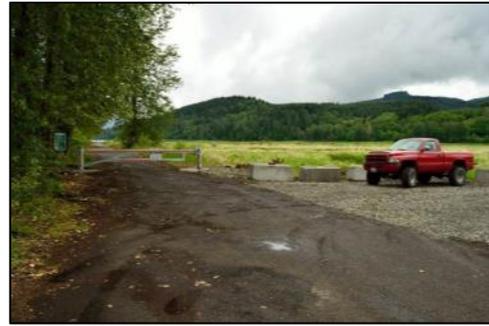
A gate and a 30' x 30' pull out were installed along the old road known locally as the Old Glenoma Highway. This "road" extends into the Kosmos Unit of the Wildlife Area to the old Kosmos town site. Vehicular traffic was restricted beyond this point since 1995 by the use of ecology blocks and signage to protect cultural resources, prevent wetland habitat destruction, and prevent wildlife harassment. This became more challenging in recent years due to vandals moving the ecology blocks and erosion around the old bridge. When the ecology blocks were removed, a potentially dangerous situation arose as a vehicle could mistakenly drive into Frost Creek not realizing the road across the bridge was eroded away. The installation of the gate blocked vehicular access to an additional 1,600 feet but mitigated the hazard to the public, continued meeting the objectives of the management plan, and did not appreciably restrict public use. Public access is preserved by seasonally opening the gate when water levels on the reservoir prevent vehicular access to the area near the bridge.

Kosmos Gate on the Old Highway

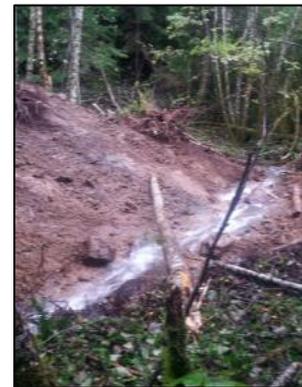
The CWA staff successfully submitted three major Road Maintenance and Abandonment Plan (RMAP) projects for environmental permitting. Two of the RMAP projects were completed in 2013. The culvert removals on the 1540 and 3000 roads were removed and the roads beyond the culverts were abandoned according to Forest Practice Standards. The culvert removal on the 1090 Road (West Road) was permitted but due to unresolved road access issues between Tacoma Power and private landowners, the project was not started. It is anticipated that the issues will be resolved in 2014 and the project completed.

1540 RD Culvert Removal
